CHERNOBYL ACCIDENT

© M. Ragheb
4/9/2011

The accident on April 26, 1986 at unit 4 of the RBMK-1000 reactors plant at Chernobyl in the Ukraine is considered as the worst accident in the history of nuclear power generation.

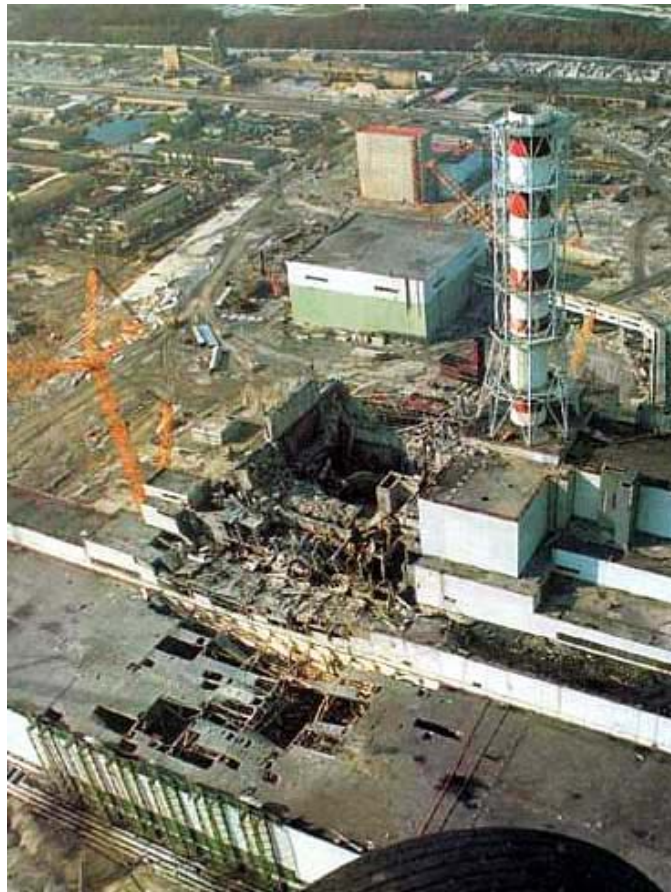
Figure 1. Damaged unit 4 of the Chernobyl plant, before being enclosed in a concrete silo.

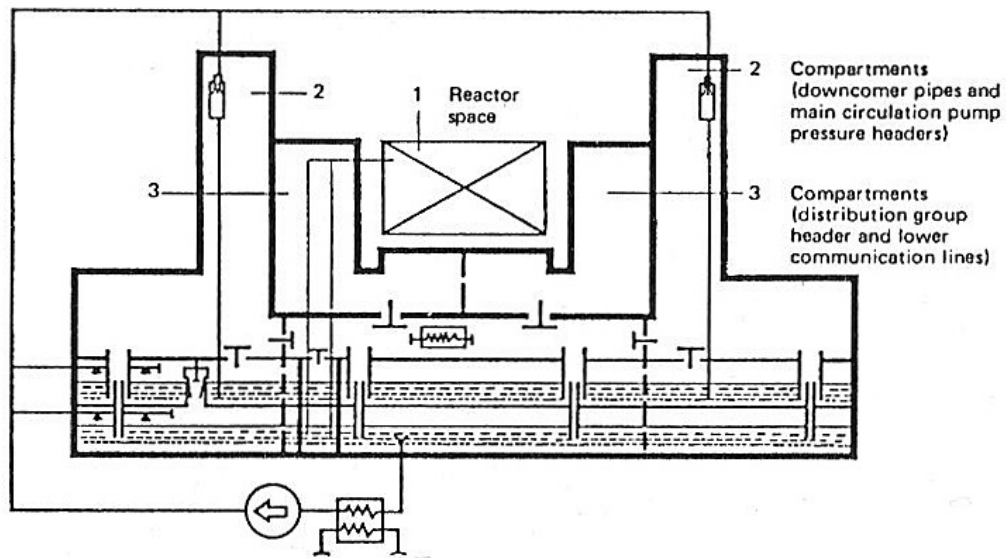
Figure 6. Schematic diagram of the containment system designated as the “accident isolation system.” A design flaw involves the placing of the pressure suppression pool under the reactor core creating the possibility of a steam explosion from the possible interaction of molten corium material with the water. Source: IAEA.

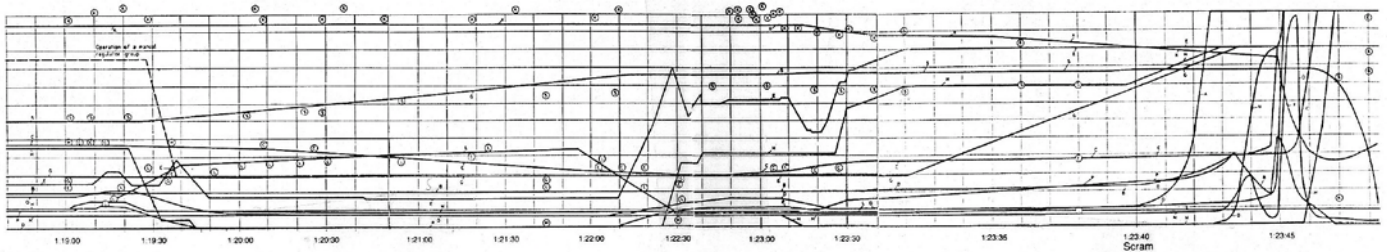
Figure 10. Accident sequence of the Chernobyl unit 4 accident. Vertical lines represent 10 second intervals from 1:19:00 to 1:23:30. At that point vertical lines represent 1 second intervals. At 1:23:43, the neutron power curve switches from A to D, with a change in the vertical scale.

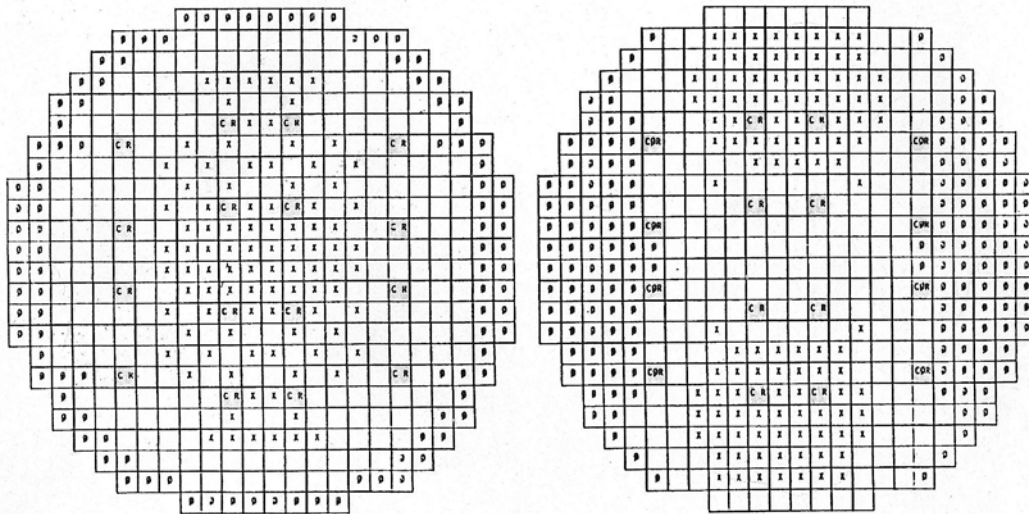
Figure 11. Initial radial power distribution (left) and radial power distribution at the time of the power excursion (right). CR: control rods, x: $P > 1.3 P_{\text{average}}$, o: $P < 0.7 P_{\text{average}}$. At the time of the accident, the core had split into two cores.

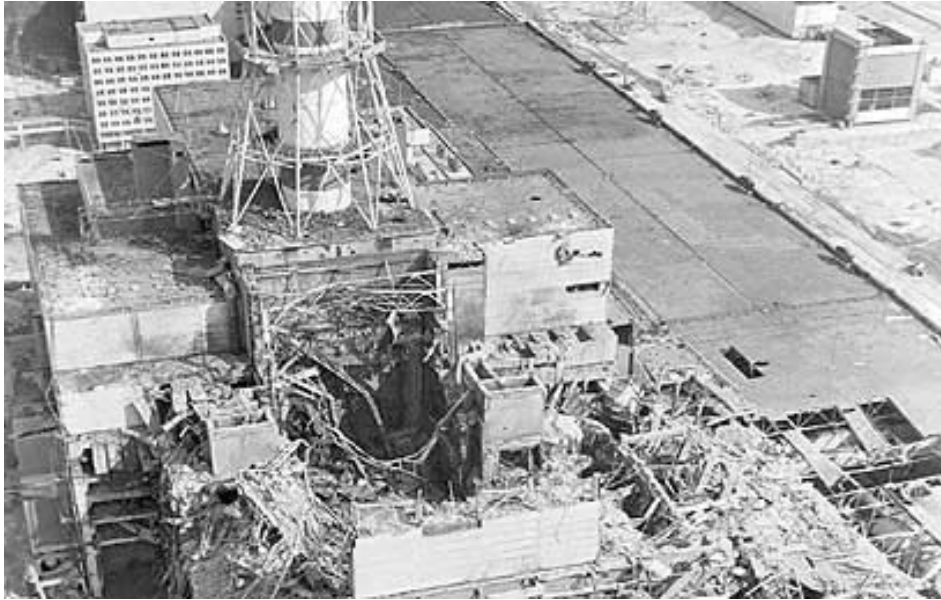
Figure 12. Aerial picture into the Chernobyl damaged unit 4 reactor core.

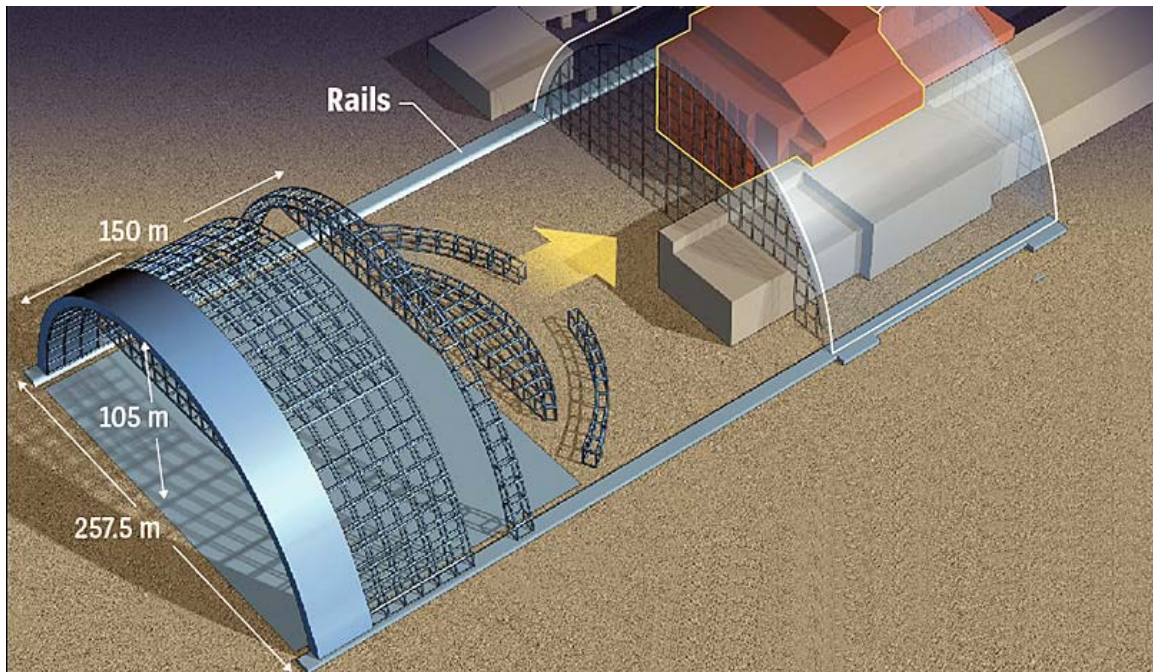
Figure 16. Proposed metallic vault for the damaged Chernobyl unit 4 reactor. The metallic shield would be constructed near the reactor then moved on rails to cover it.
Source: Der Spiegel.

The concrete silo encasing the burned reactor at Chernobyl is crumbling, threatening to leak radiation through the effects of wind, rain and snow.
