FUKUSHIMA EARTHQUAKE AND TSUNAMI STATION BLACKOUT ACCIDENT

INTRODUCTION

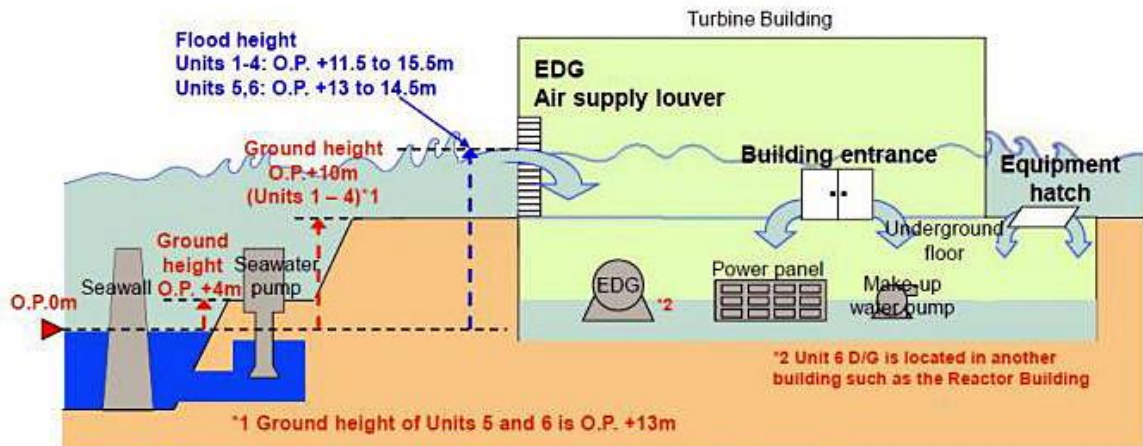
Figure 9. Inundation paths of major buildings at Fukushima plants.

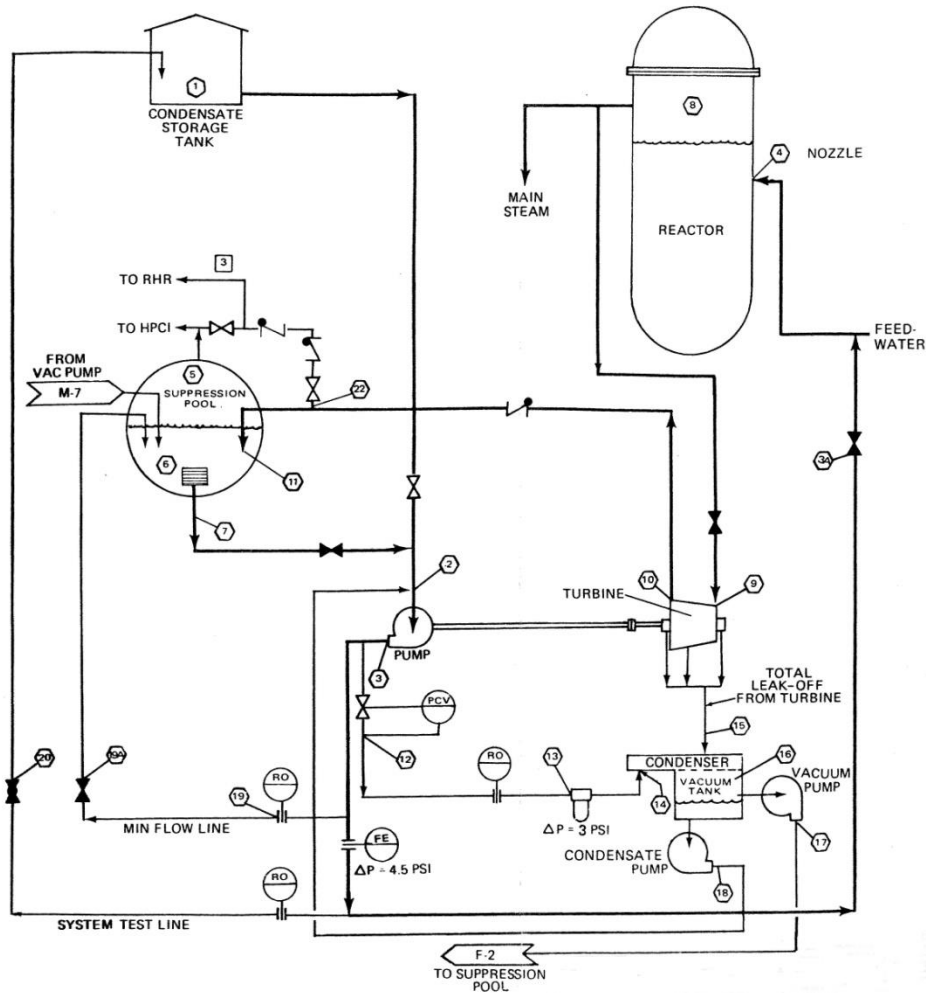
Figure 14. BWR Reactor Core Isolation Cooling system, RCIC. A steam turbine uses steam to drive a pump injecting water drawn from the condensate storage tank into the core. Exhaust from the steam turbine is directed to the pressure suppression pool. HPCI: High Pressure Coolant Injection system, RHR: Residual Heat Removal system.

Failure of the reactor cooling function carried out by the Reactor Core Isolation Cooling, RCIC system occurred in units 1, 2 and 3 at the Fukushima Daiichi site and at unit 4 at the Fukushima Daini site; a situation stipulated in article 15, clause 1 of the “Act on Special Measures Concerning Nuclear Emergency Preparedness” in Japan.

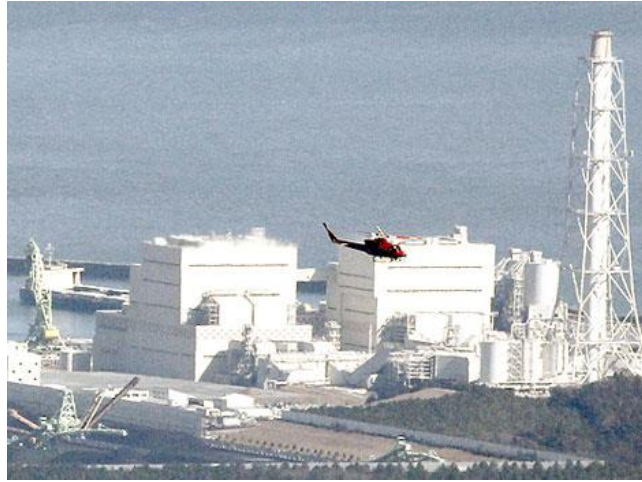
Figure 16. Steam appears to be leaking from top of left containment structure prior to hydrogen explosion. Source: Reuters.

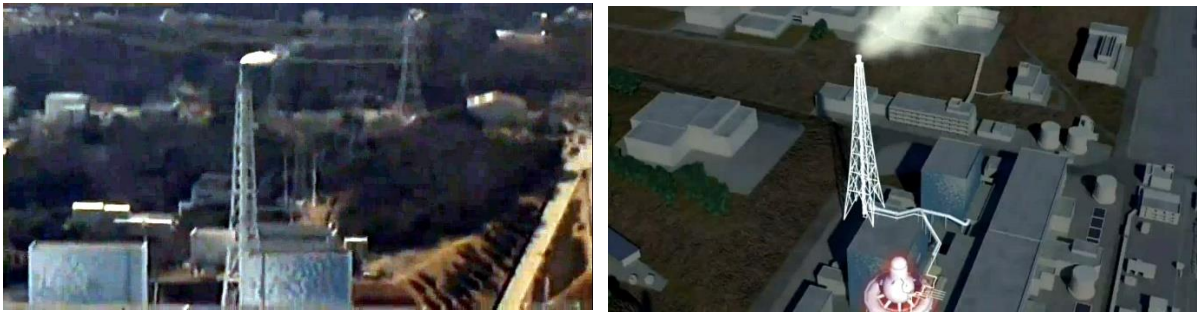
Figure 17. Venting primary containment of unit 2.

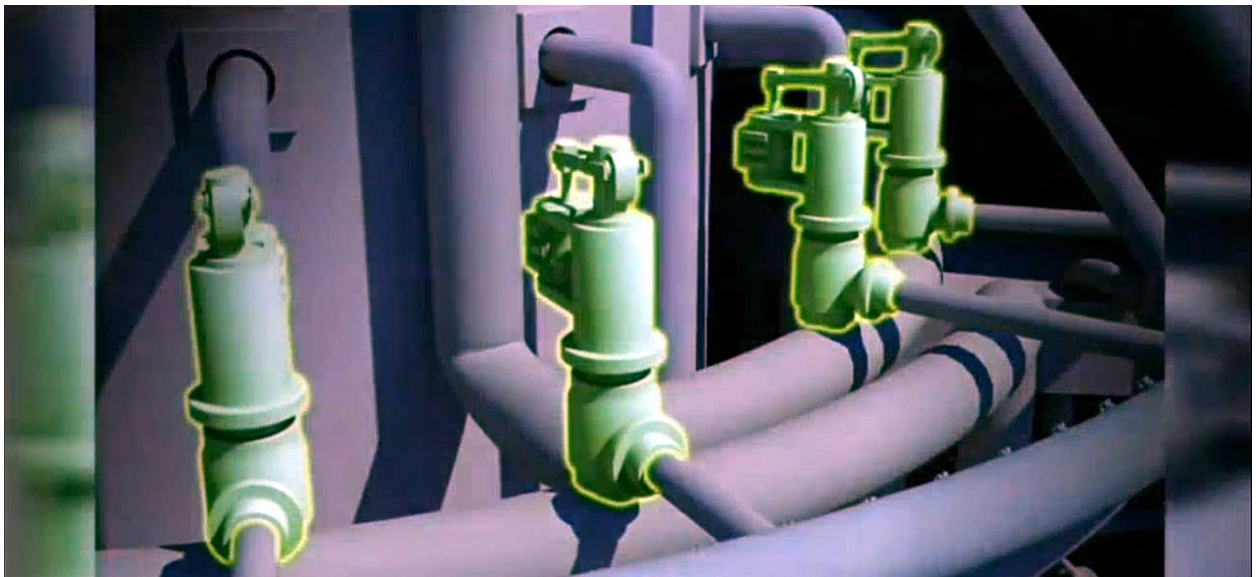
Figure 19. Bank of 8 safety relief valves of the primary containment failed to operate to vent the hydrogen and steam pressure from the containment.

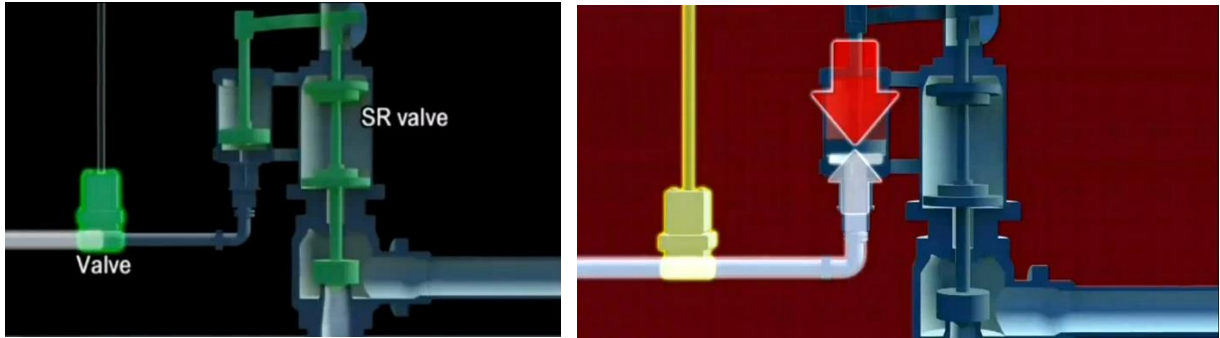
Figure 20. Battery-operated auxiliary valve releases nitrogen pressure to open safety relief valve to vent the containment of hydrogen and steam failed to operate because of unexpected high pressure in the containment that countered the nitrogen pressure. Operators tried to use connected car batteries to operate it unsuccessfully.

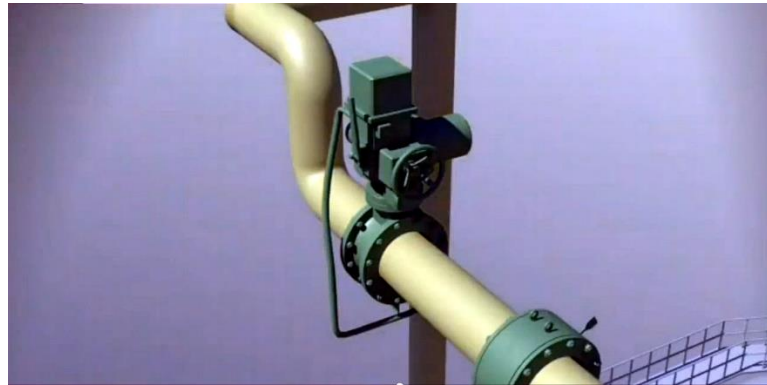
Figure 21. Manually-operated safety relief valve.

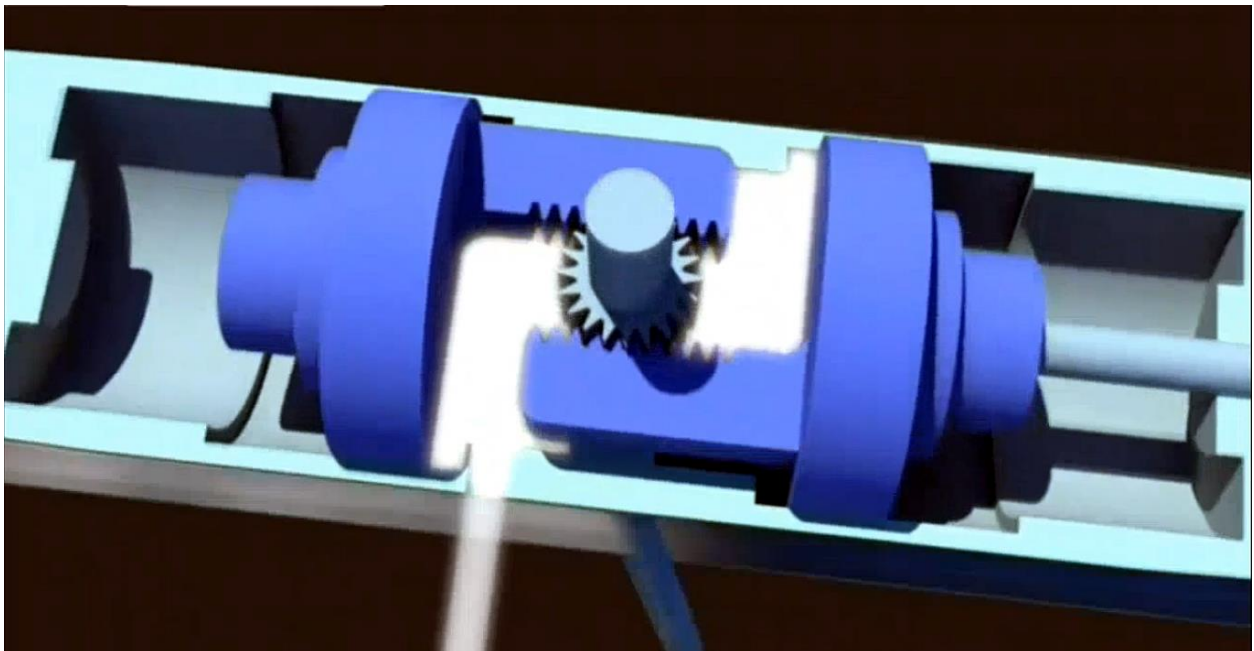
Figure 22. Remote controlled compressed air safety relief valve. Failed to operate due to pressure loss in the compressed air lines.

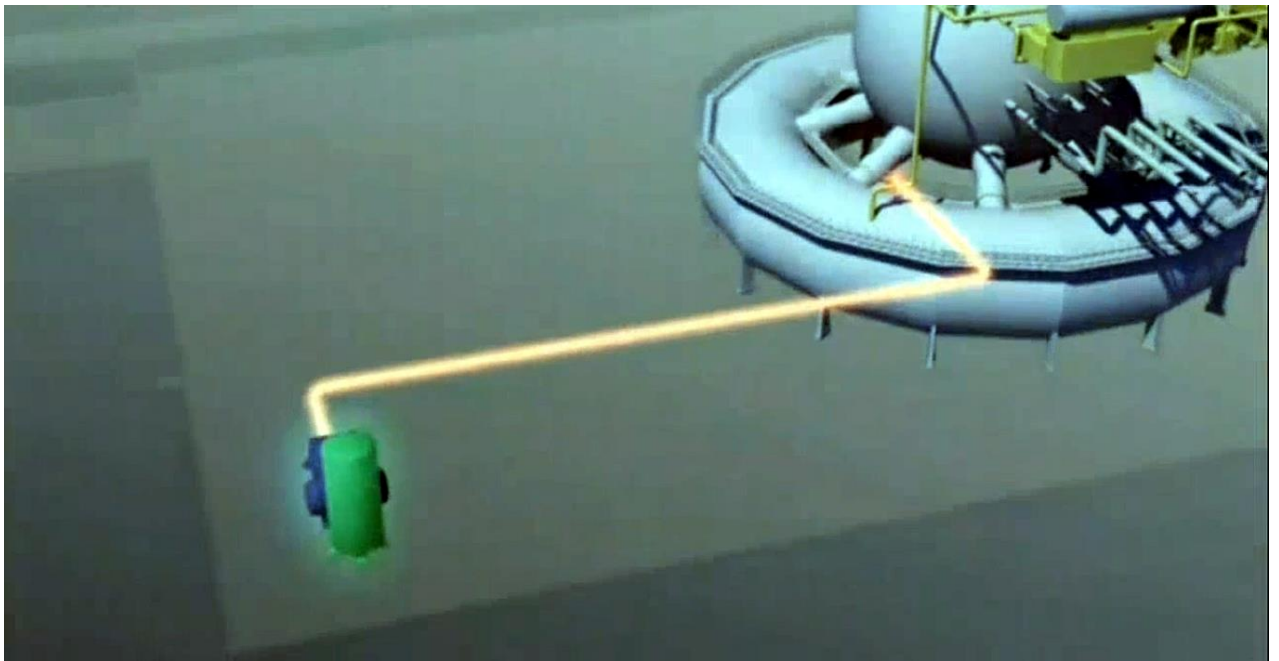
Figure 23. Compressed air containment venting valve failed to operate because of suspected loss of pressure in compressed air lines due to earthquake damage.

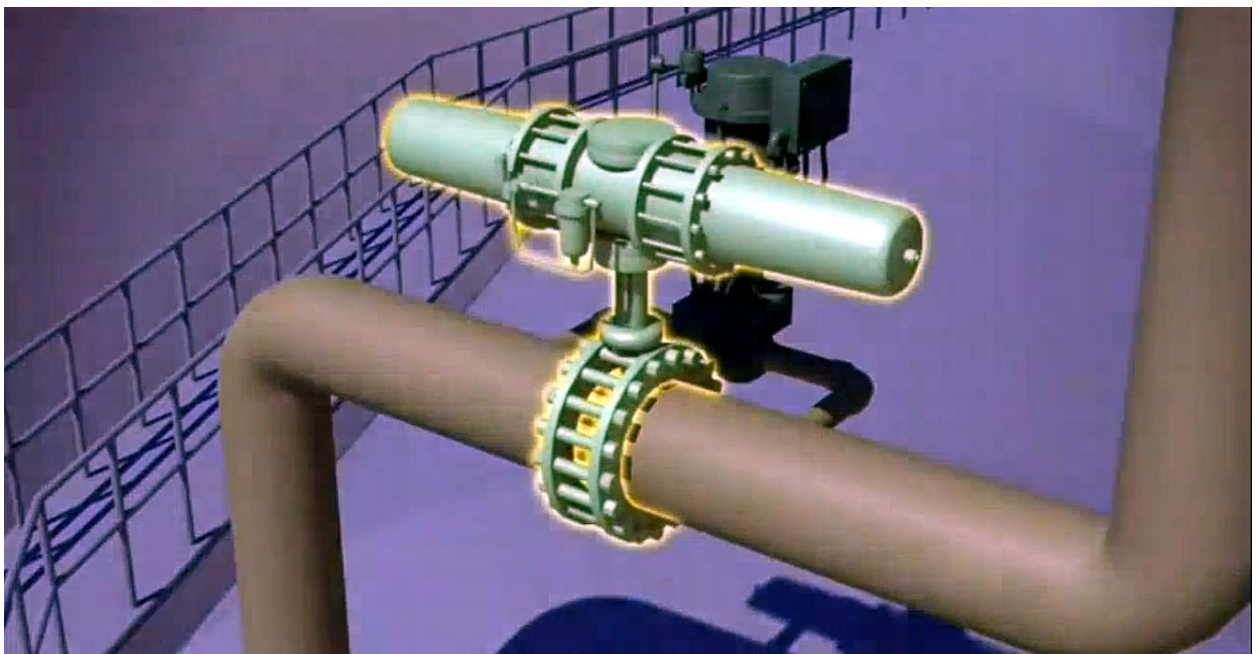
Figure 24. Second non-manually operated relief valve.

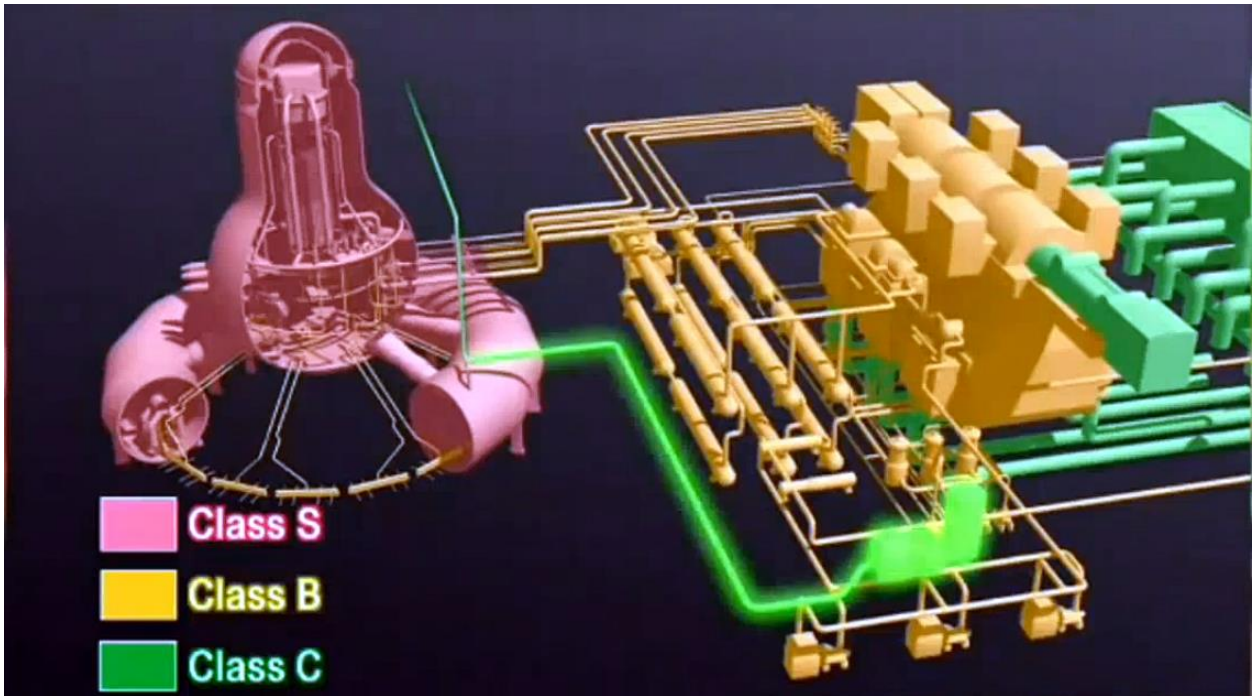
Figure 25. Seismic class C air duct to venting valve may have sustained cracks as a result of the earthquake.

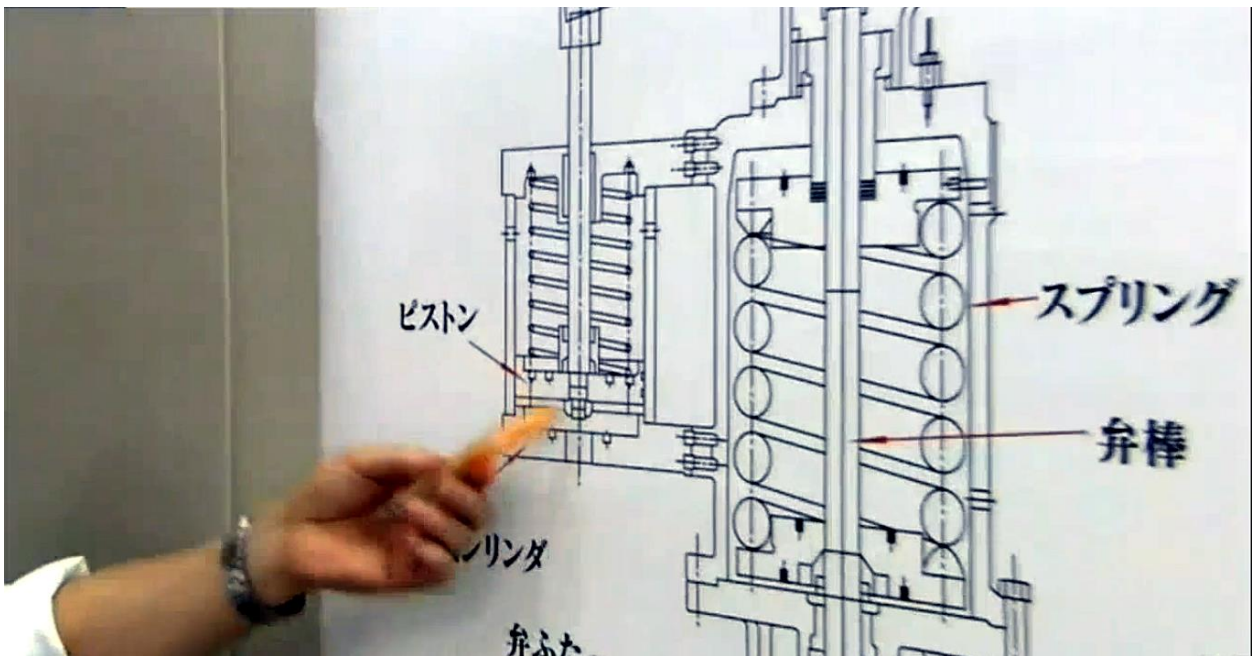
Figure 26. Safety relief valve design.

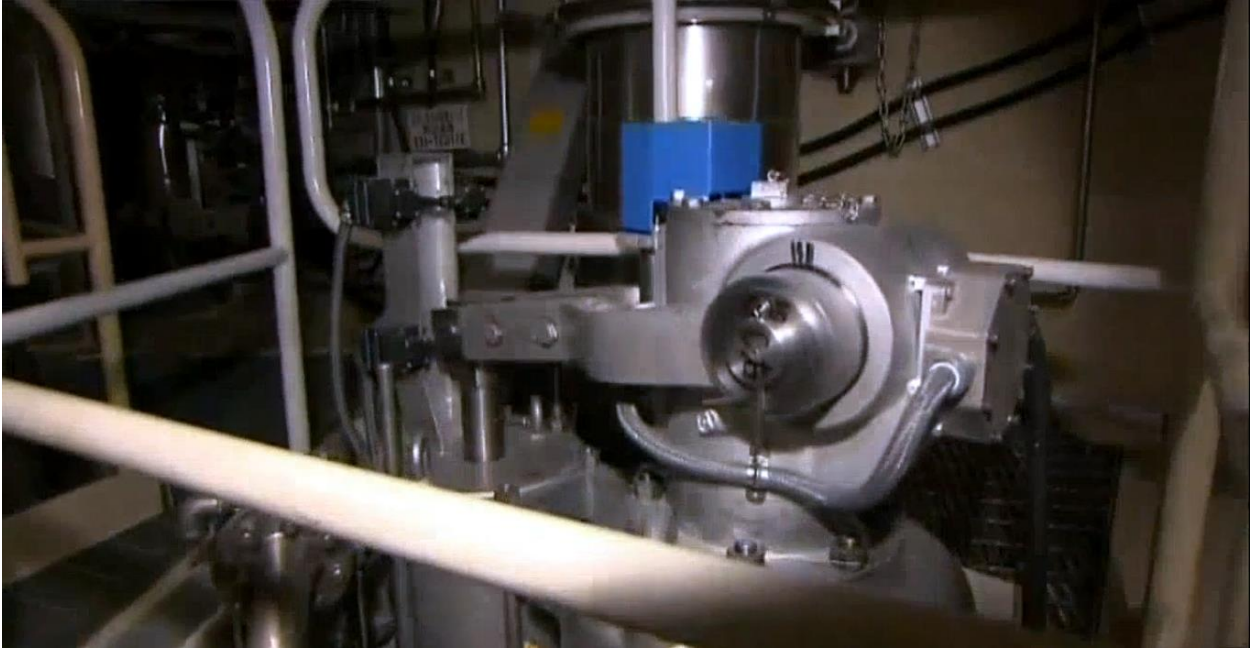
Figure 27. Safety relief valve picture.

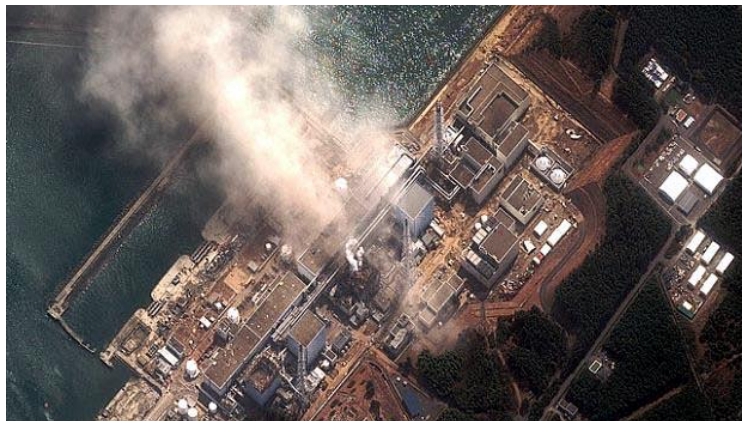
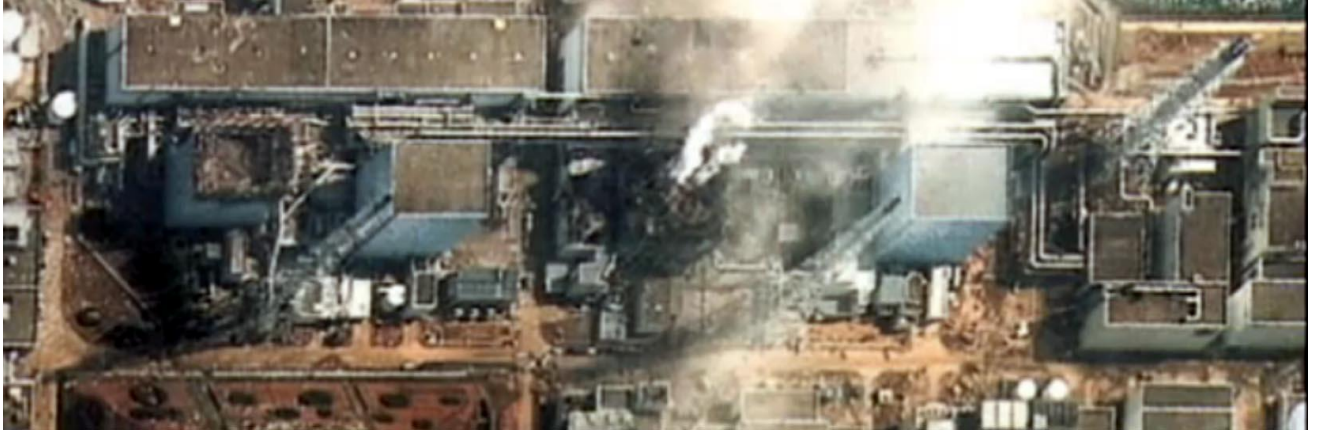
Figure 30. Remnants of a hydrogen explosion in Fukushima unit 1 (far left) exposing reactor loading deck and burying it under concrete rubble. Fire and a hydrogen explosion associated with steam depressurization and fuel damage occurred in unit 3. Fire starting at side of building in unit 4 may have originated from hydrogen generated in unit 3 that was piped into the shut-down unit 4, on March 15, 2011. Photo: DigitalGlobe.

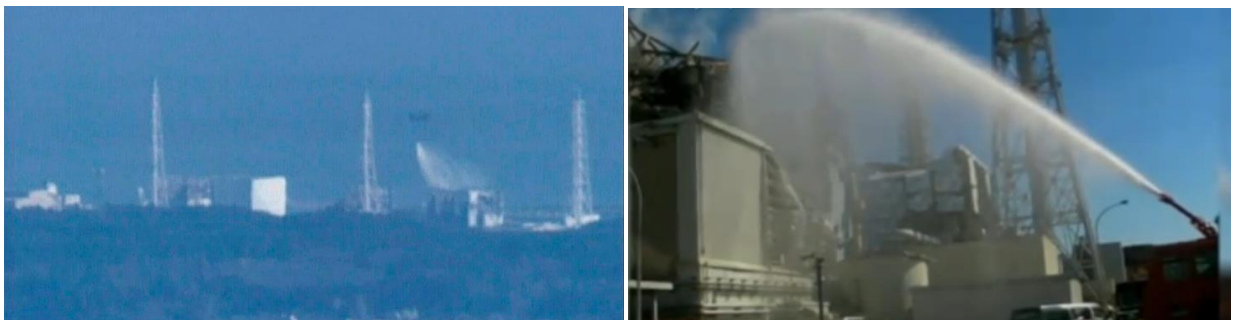
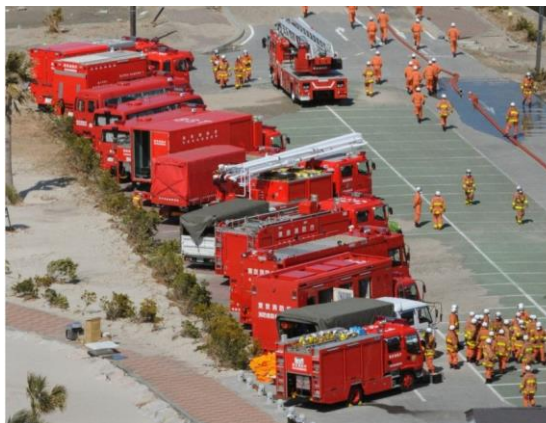
Figure 31. Military helicopters dumping water into fuel storage pools on March 17, 2011, were ineffective because of high winds. They were replaced by water cannons from fire trucks on March 18, 2011 to extinguish fires and add water to the fuel storage pools. Source: Japan Self Defense Forces.

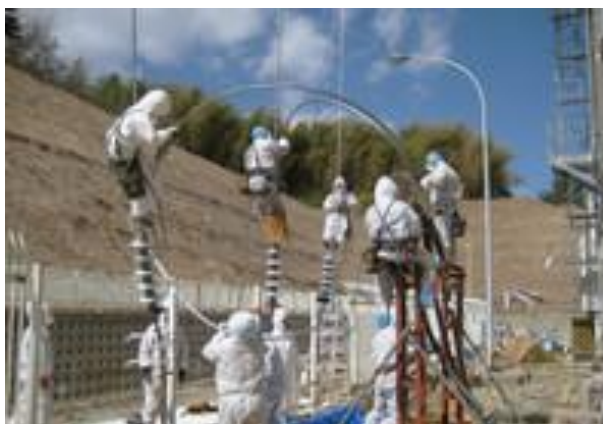
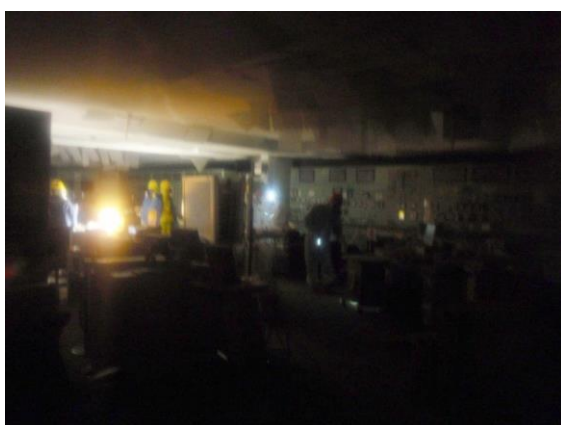
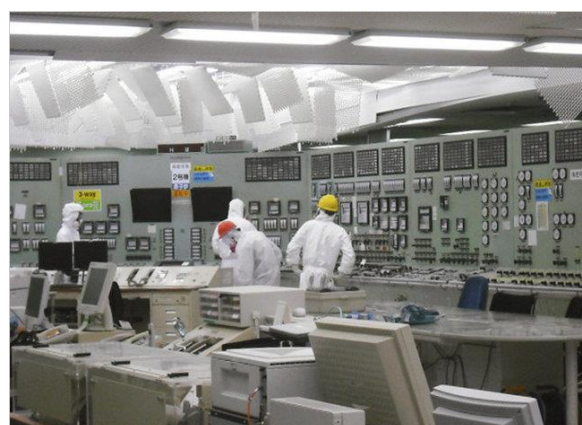
Figure 32. Station Blackout loss of power to the control room of the Fukushima Daiichi unit 1 reactor on March 24, 2011. Restoring offsite power to units 1 and 2 and power to the control room of unit 2 on March 26, 2011. The hanging ceiling tiles resulted from the earthquake. Source: Tepco.

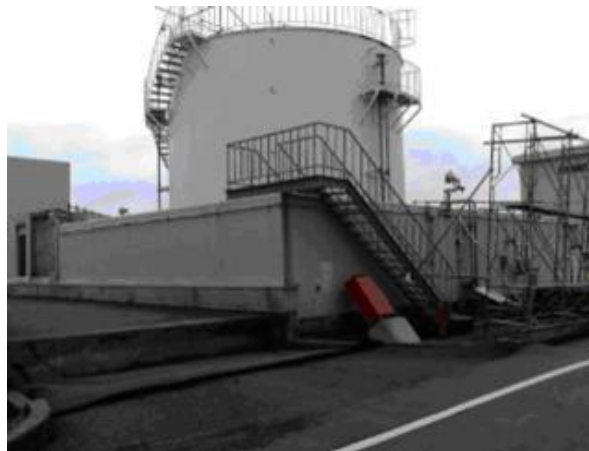
Figure 33. Earthquake-caused ground subsistence around light oil storage tank of 30,000-40,000 gallons capacity, 1979. Source: Tepco.

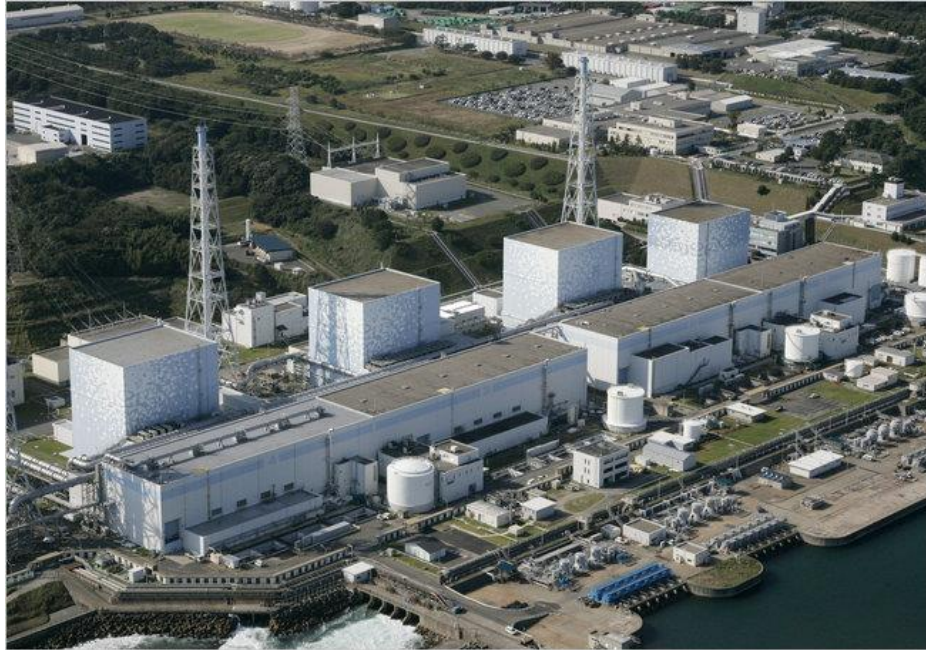
Figure 35. Fukushima Daiichi Boiling Water Reactors, BWRs nuclear Power plant, at Okumamachi, Fukushima Prefecture, Japan. The reactors are cooled with ocean water and are situated 148 miles or 238 km northeast of Tokyo. Connection to the grid shows up at the upper left side. Source: AP.

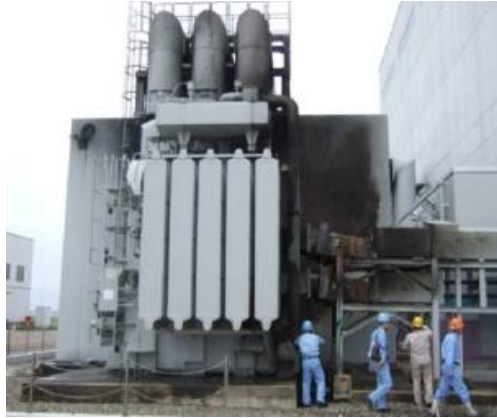
Figure 37. Transformer fire caused by 1979 earthquake. Notice the location of the transformer outside the plant enclosure and its vulnerability to water-flooding from the tsunami event.
Source: Tepco.

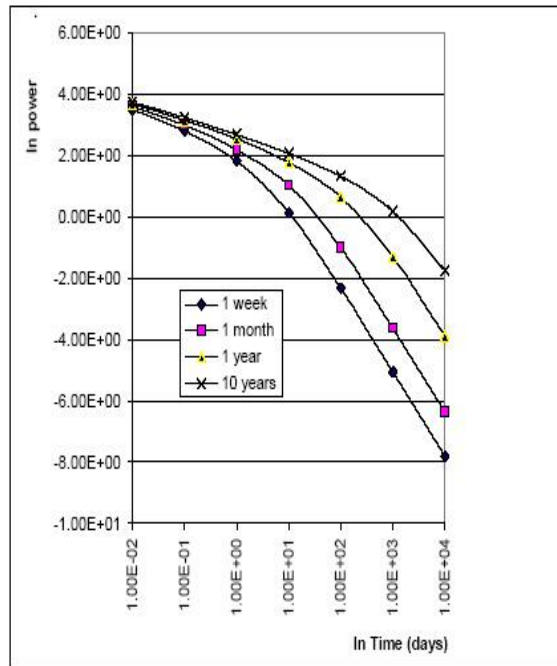
Figure 38. Decay heat power release for a 3,000 MWth Light Water Reactor, LWR for different operational times. The decay heat generation power decreases rapidly within a few days after shutdown.

Upon shutdown of the fission power generation by the control rods, decay heat continued to be generated to an initial level of about 3 percent of the fission power at one minute after shutdown. It decreases exponentially as a function of time but must continue to be cooled over a few days period by the Residual Heat Removal, RHR system.

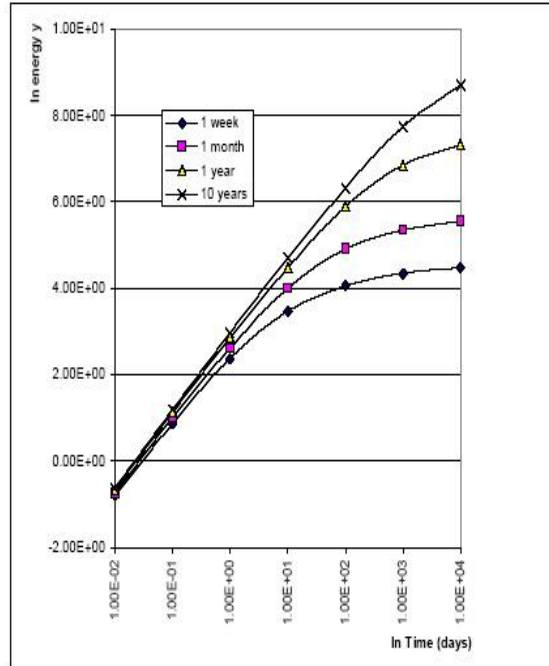
Figure 39. Decay energy or integrated power release after shutdown for a 3,000 MWth LWR for different reactor operational times. If not extracted and rejected, the energy released would result in fuel damage including fission products release and hydrogen generation.

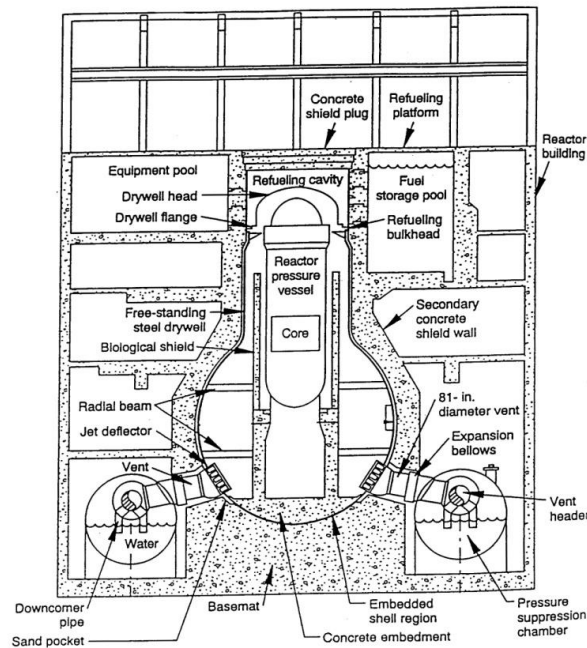
Figure 40. Primary and secondary containments configuration at Fukushima plants.

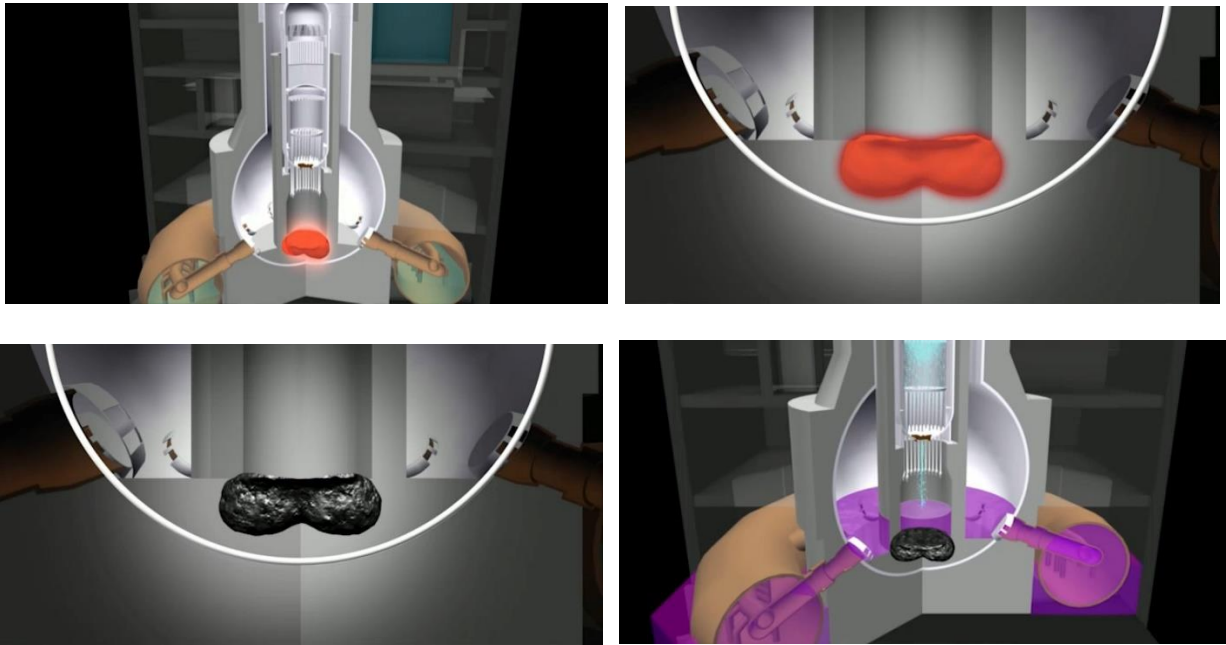
Figure 43. Molten corium material leaked through the control rods graphite seals into the dry well in the primary containment vessel. Dry well flooded through water injection from the top of the core. Source: Tepco.

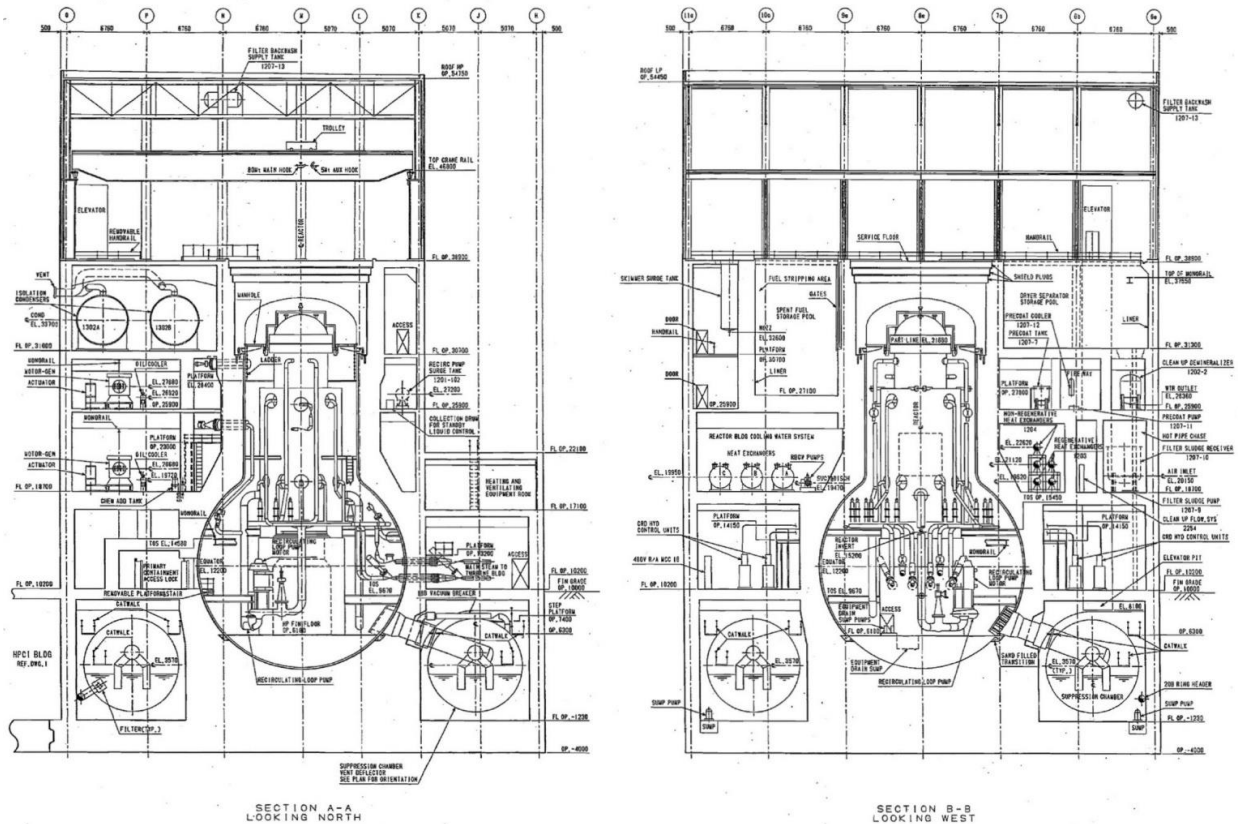
Figure 44. BWR Mark I, light bulb design showing the toroidal steel pressure suppression pool, and the gate between fuel storage pool and reactor top. Source: GE, Japan Ministry of Economy, Trade and Industry, METI, Tepco.

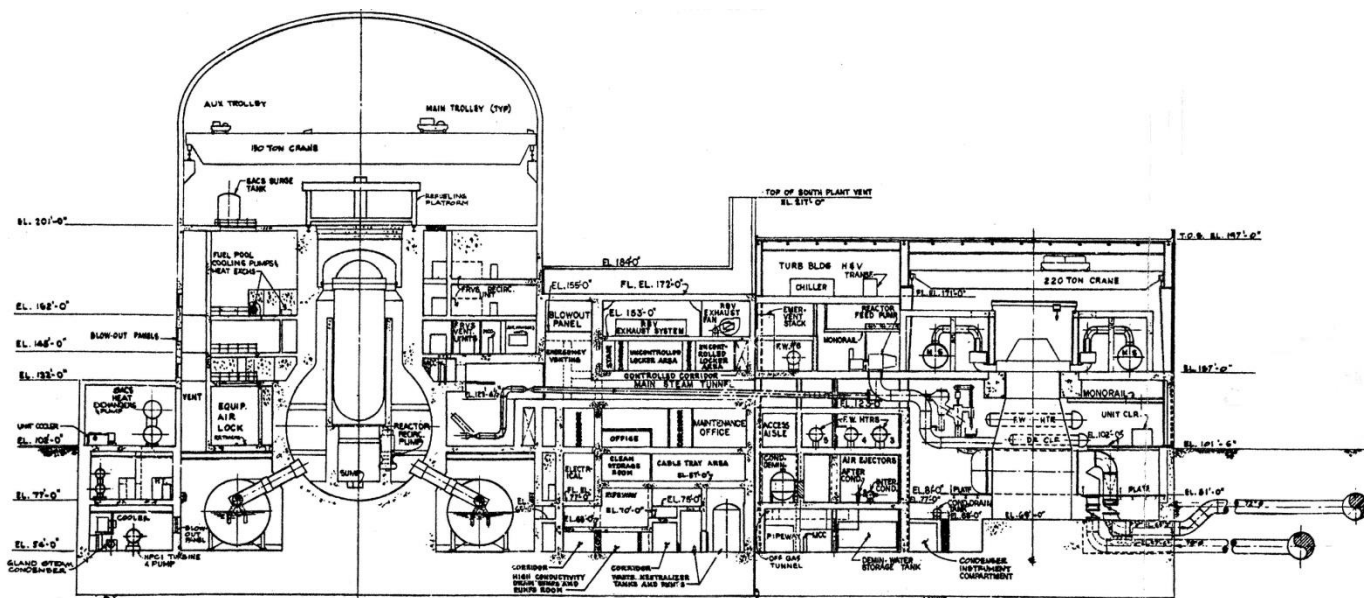
Figure 45. Cutout through containment and turbine hall showing the location of the fuel storage pool in a typical BWR. Plant systems below grade level and hence affected by flooding from the tsunami event include pumps and electrical components. The dry well includes a sump. Any leaking corium material through the control rod seals could interact with the sump water as well as the concrete mat causing a steam explosion, then becoming embedded in the concrete. Source: GE.

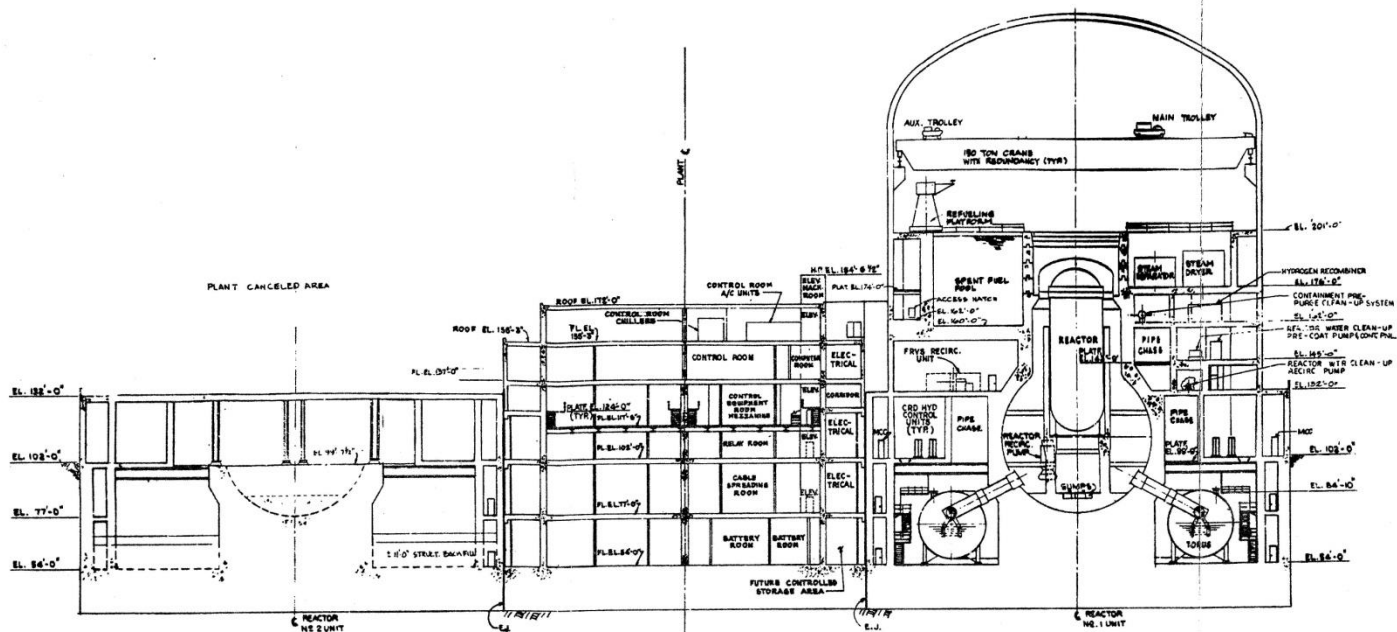
Figure 46. Perpendicular cutout through the containment structure showing the location of the storage batteries. The gate and other connections between the fuel storage pool and the top of the core may have sustained damage as a result of the earthquake and caused leakage of the pools' cooling water. Source: GE.

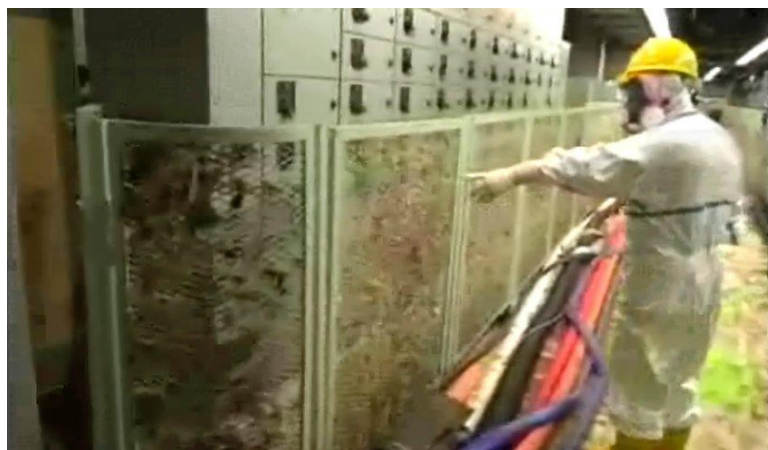
Figure 47. Tsunami water flooding of electrical switching components in basement of unit 1, May 6, 2011. Source: Tepco.

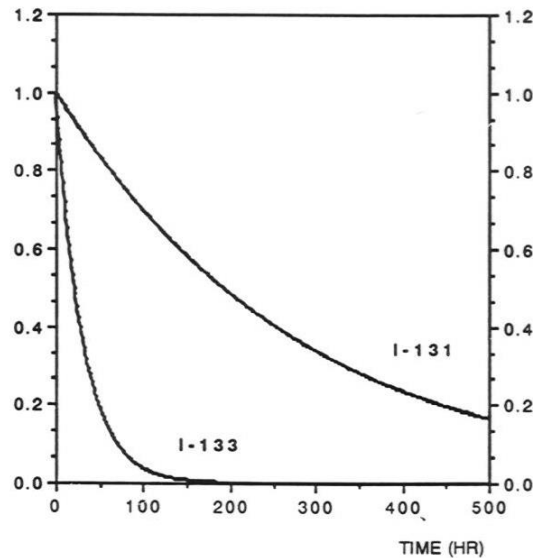
Figure 48. Decay curves of two short lived fission product isotopes, I¹³¹ and I¹³³.

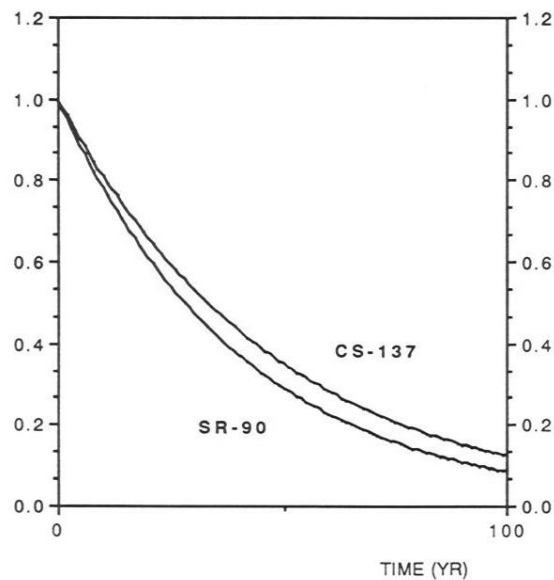
Figure 49. Decay curves of the two long lived fission product isotopes, Cs¹³⁷ and Sr⁹⁰.

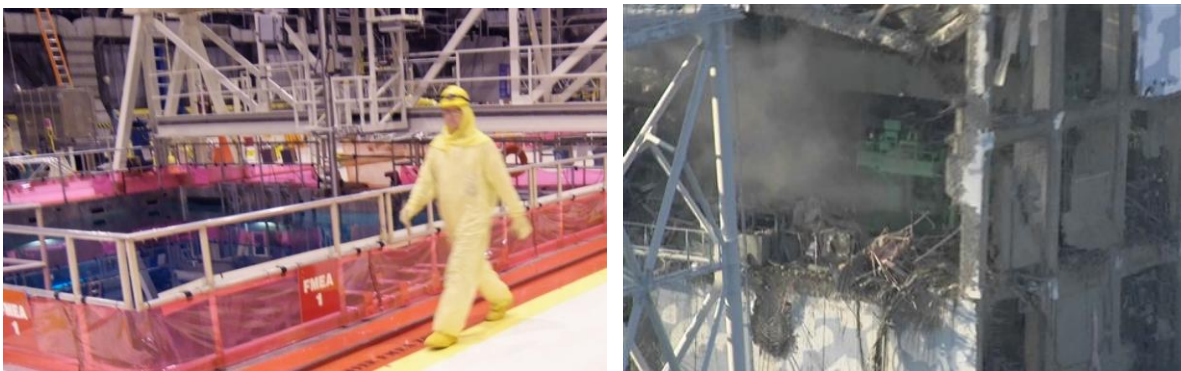
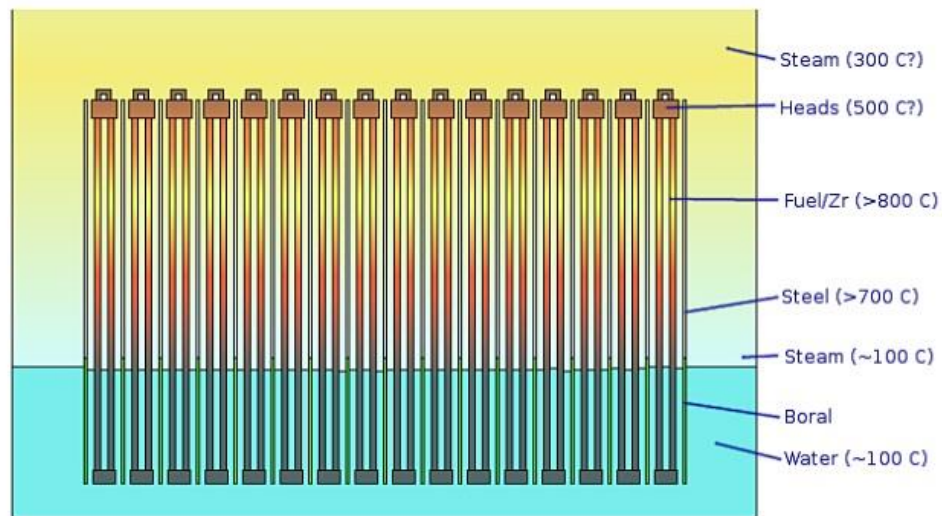
Figure 50. Spent fuel storage pools (top) showing fuel assembly being moved through gate between pool and reactor top. Steam emanating from fuel storage pool in unit 4 on March 15, 2011, under the loading crane showing at the center of the picture.

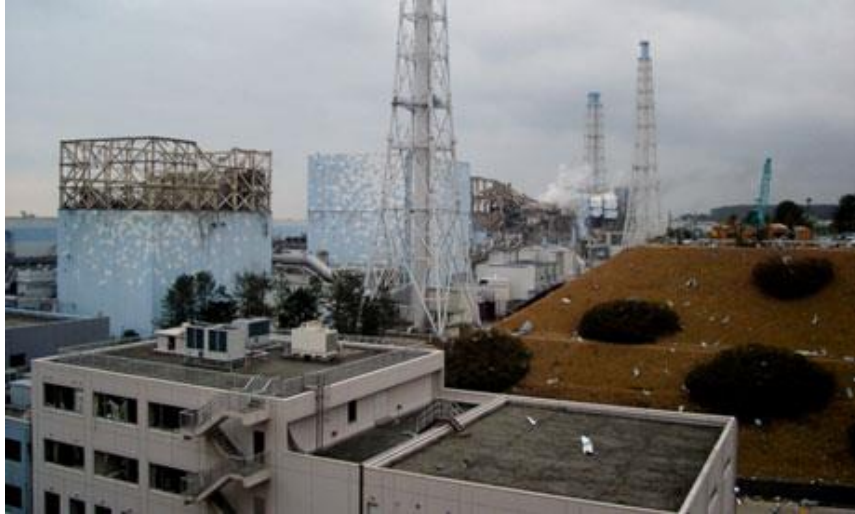
Figure 52. Damage to the upper structure of the Fukushima Daiichi unit 1, and undamaged structure of unit 2. Source: Tepco.

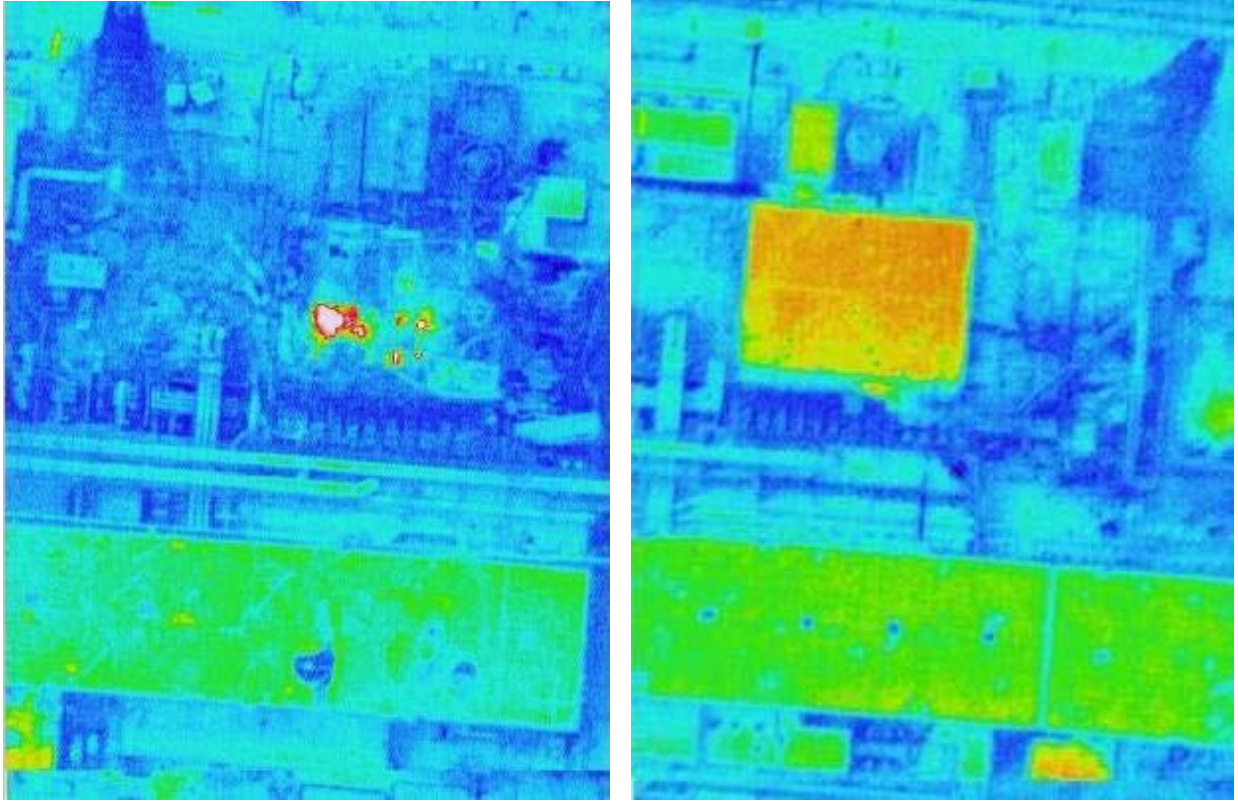
Figure 53. Infrared signatures of Fukushima units 1 and 2 (right) suggesting a temperature of 262 °F in unit 2 and of units 3 and 4 (left) suggesting a lower temperature of 144 °F on March 21, 2011 in reactor building and turbine hall caused by accumulated unvented steam. A heat plume at the bottom of the reactor building of unit 2 suggests steam leakage from the undamaged building structure. A heat signature exists in unit 1 to the far right. Unit 4 does not exhibit a heat signature. Highly localized heat signature in unit 3 may suggest a possible ejection of the concrete shield plug by the observed hydrogen or possibly steam explosion. Atmospheric pressure measurements at units 2 and 3, but not unit 1, suggest containment breach by April 10, 2011. Source: Tepco.

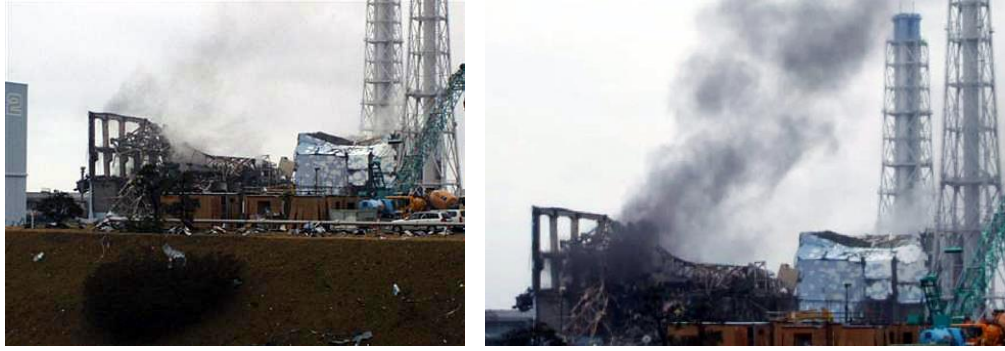
Figure 54. Fukushima Daiichi Unit 3. Steam emission on March 21, 2011 evolved into black smoke. A possible hydrogen or steam explosion tore out the upper part of the containment building structure. The blow-out-panels are missing, with remaining steel and concrete beams. The reactor containment vessel is reported to remain intact, even though the nuclear fuel storage pool and the reactor refueling deck would be exposed to the elements. Steam and dark smoke emanating from possible burning of the UO_2 fuel, concrete rubble, or boron carbide B_4C embedded in the Al of the Boral shielding material if it is used in the fuel storage pool as spacer between the fuel assemblies. Source: Tokyo Electric Power Company.

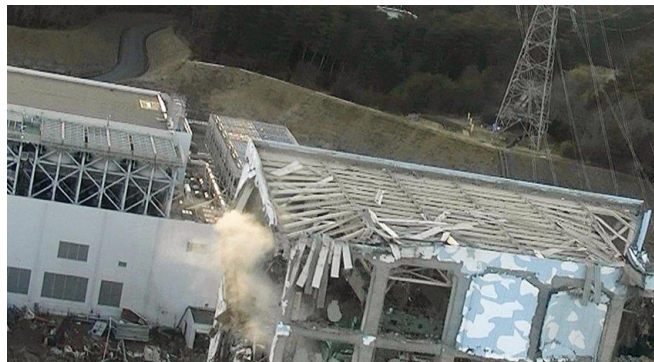
Figure 55. Fukushima Daiichi unit 4 on March 16, 17, 2011 showing steam emanating from fuel storage pool. Source: Japan Self Defense Force.
