FUKUSHIMA EARTHQUAKE AND TSUNAMI STATION BLACKOUT ACCIDENT

INTRODUCTION

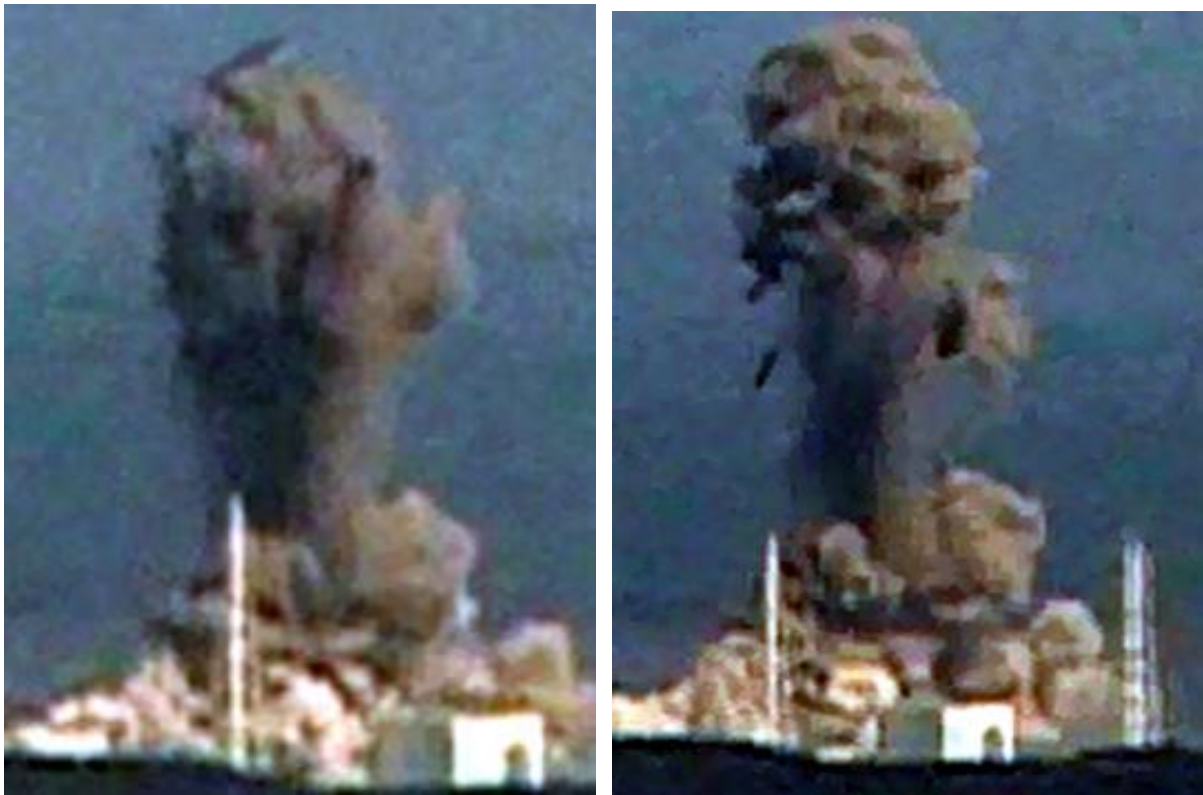
Figure 59. Highly energetic vertically propagating hydrogen or possibly steam explosion at the Fukushima Daichi unit 3 BWR on March 14, 2011 was followed by a fire and reactor fuel damage. Heavy debris possibly composed of the concrete shield plug or crane components was vertically ejected and is seen falling back down in the photograph. No damage to the reactor vessel can be inferred from the absence of the reactor's top plug in the ejecta. It bears some analogy to the complex aerodynamics of an "exploding vortex ring." Sources: NTV / NNN, Japan.

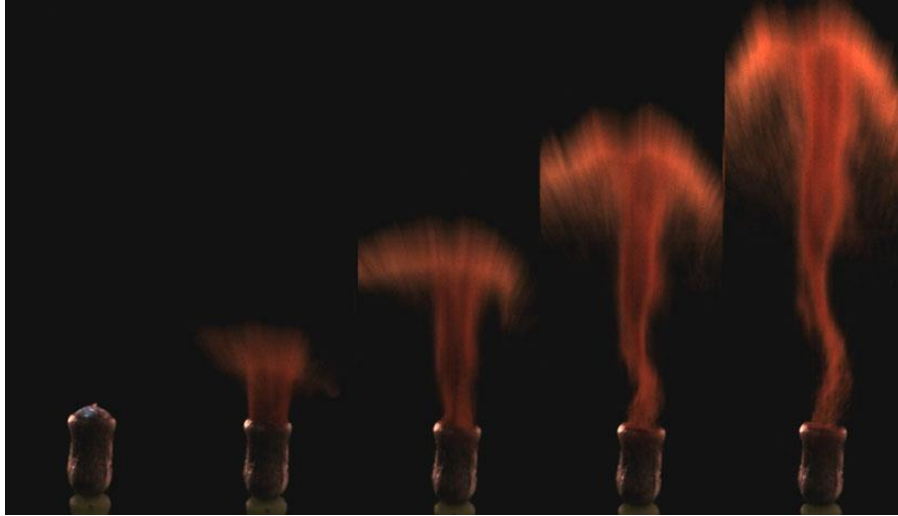
Figure 60. Exploding vortices suggest a steam explosion occurrence at unit 3.

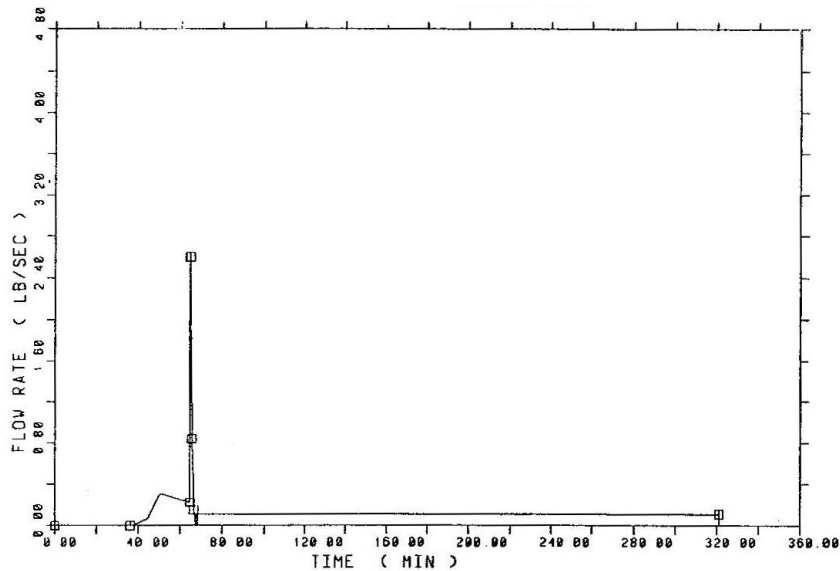
Figure 61. Hydrogen release rate was correlated with a pressure pulse inside the containment structure in the Three-Mile Island Accident. The hydrogen pulse did no discernible damage to the containment structure.

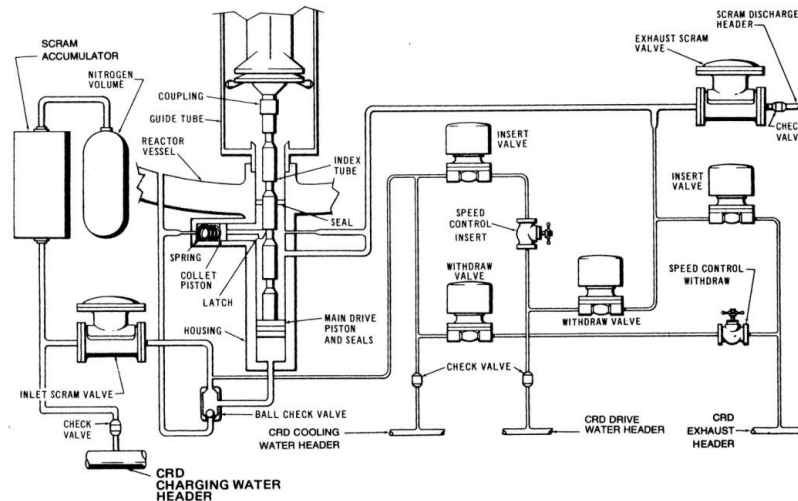
Figure 63. BWR control rod drive mechanism at the bottom of a BWR reactor vessel showing the control rod graphite seals location [2].

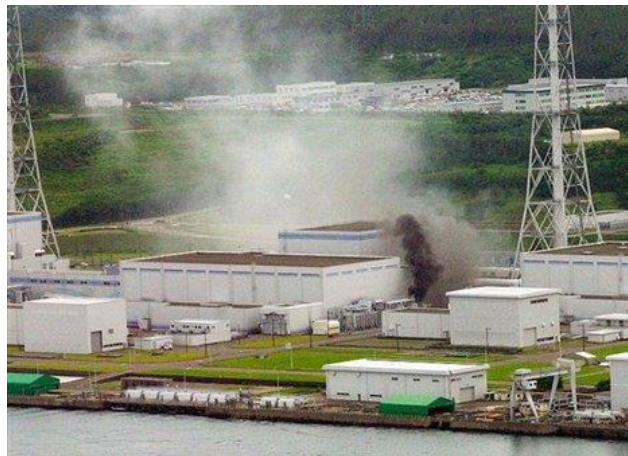
Figure 69. Burning electrical transformer resulting from the coupled earthquake and tsunami event, March 11, 2011. Source: Japan Coast Guard.

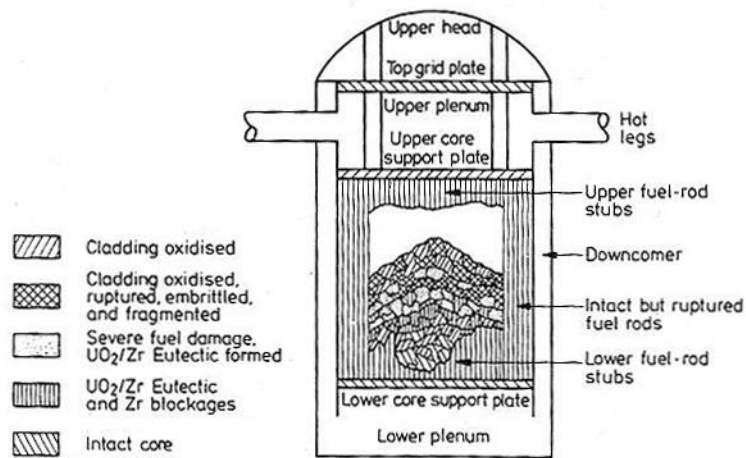
Figure 73. Debris bed resulting from the core damage in the Three Miles Island accident.

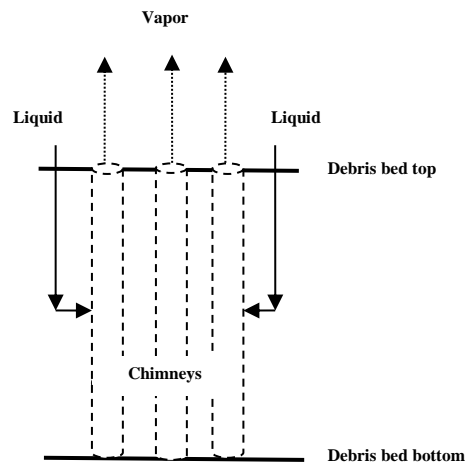
Figure 74. Debris bed chimneys cooling.

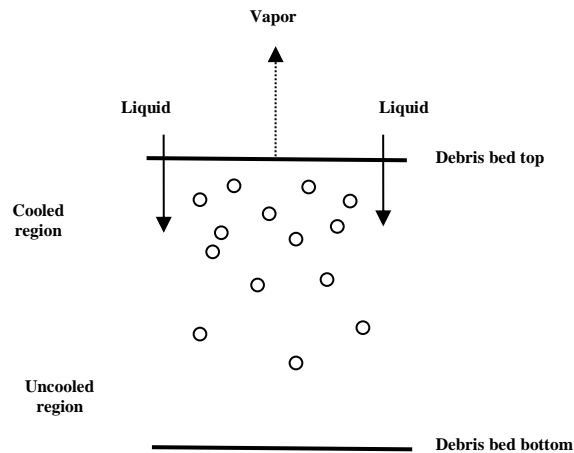
Figure 75. Closed bed debris bed cooling.

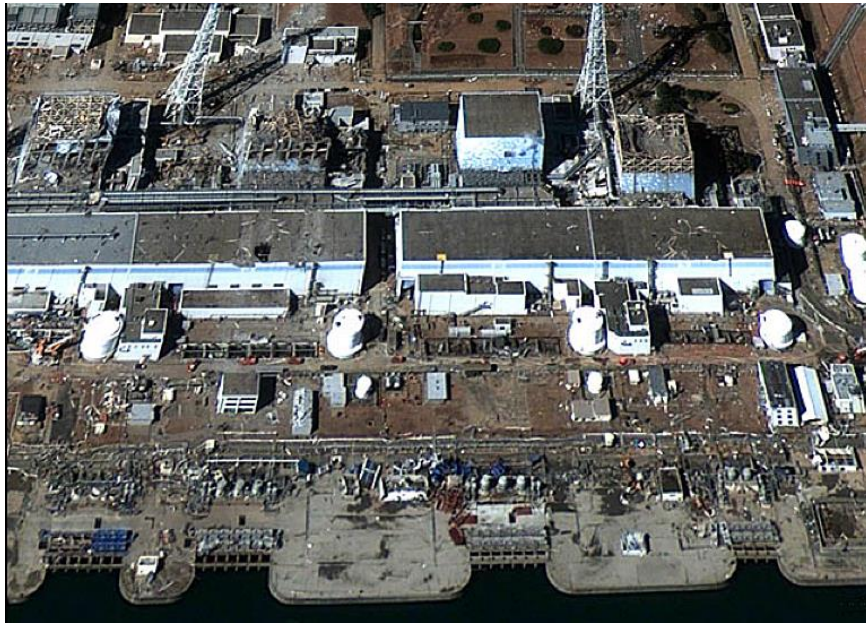
Figure 78. Aftermath of Fukushima Daiichi accident on March 11, 2011, one week after the accident. Rubble from hydrogen explosions in units 1, 3 and 4 and fire in unit 3 is spread over the site. Damage from earthquake and tsunami to the electrical systems apparent along the water front. Steam still emanating from unit 2. Source: Digital Globe.

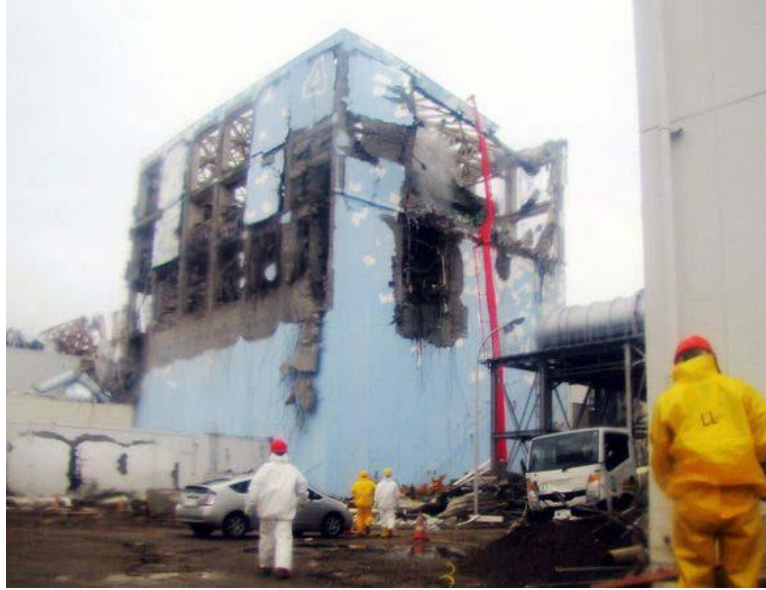
Figure 84. Damage below the fuel storage pool in unit 4 as seen from the ground on March 22, 2011. Water being pumped into the damaged spent fuel pool using a boom. Source: Tepco.

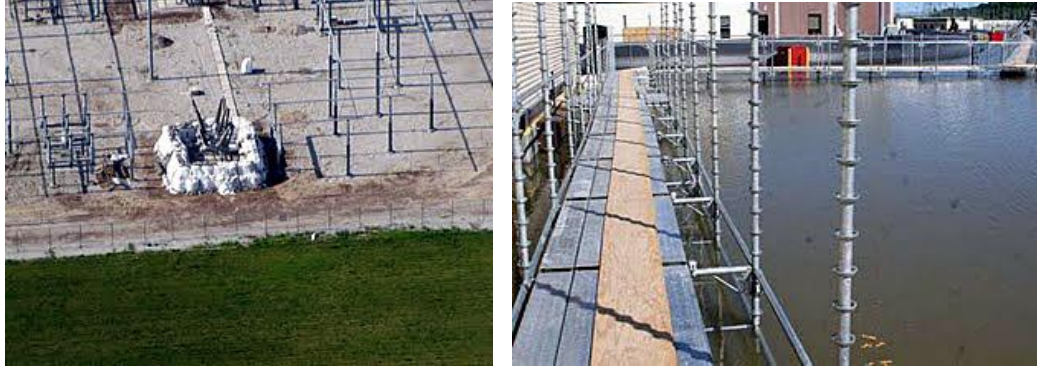
Figure 89. Circuit breaker 345 kV at transformer substation protected with sandbags and walking bridges around buildings were implemented against flooding at Fort Calhoun, Nebraska, June 13, 2011. Source: OPPD.

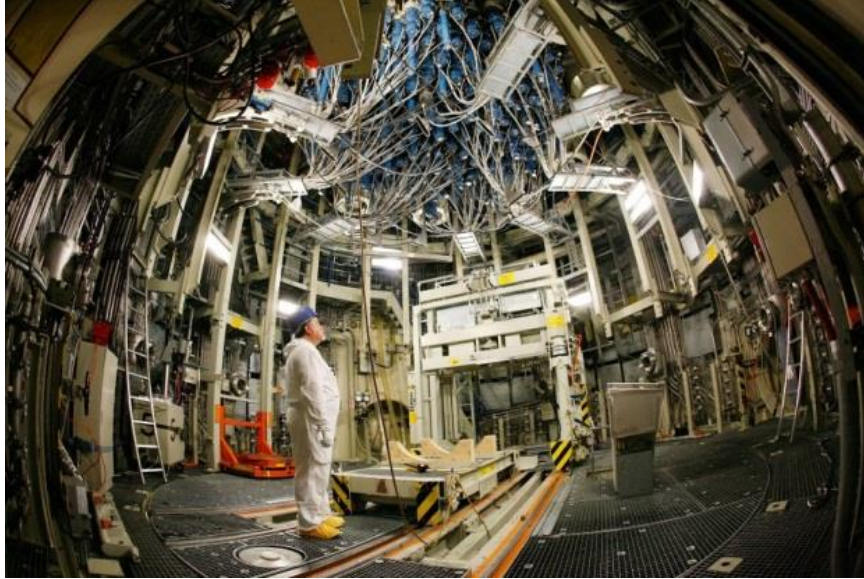
Figure 90. Control rod drives at the bottom of the Krümmel BWR reactor near Hamburg, Germany that went into operation in 1984.

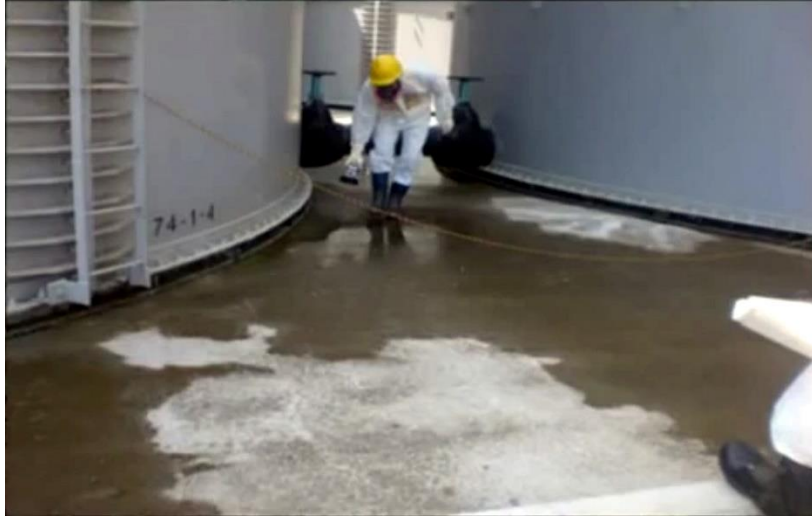
Figure 92. Leaking water storage tanks.
