Station Blackout Accident at Fukushima SAFETY

An analysis of the phenomenology of the earthquake and tsunami-induced station blackout accident at the Fukushima Daiichi plant, Japan and its consequences, is attempted. Substantial fuel damage and partial core meltdowns are surmised to have occurred in units 1, 2 and 3 with flooding in the reactors basements from suspected leaks in the piping to the containment vessels. Core uncover occurred in unit 1 at 5 hours after the combined earthquake-tsunami event with the fuel temperature reaching 2,800 °C at 6 hours into the event. Partial core damage of unit 1 with the formation of a debris bed at the bottom of the core occurred at 16 hours into the accident with its reactor building's basement flooded under 4.2 m of water. The pressure vessels of units 2 and 3 are likely to be damaged and leaking water from their bottoms. Units 4-6 were not operational and were shut-down for maintenance. However, hydrogen produced in the fuel damage of unit 3 flowed through a gas treatment line into unit 4 through damaged valves, leaked through ducts on the 2nd, 3rd and 4th floors and caused a fire and explosion. Hydrogen explosions occurred in the units

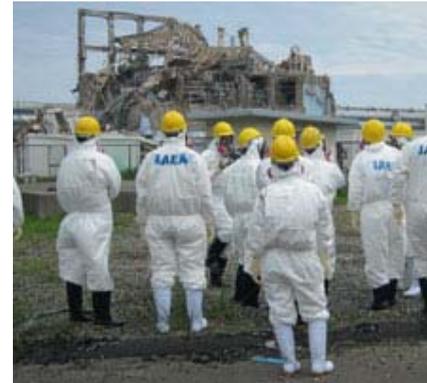
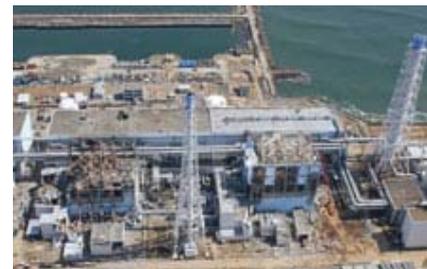
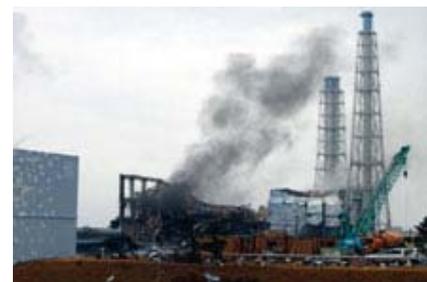
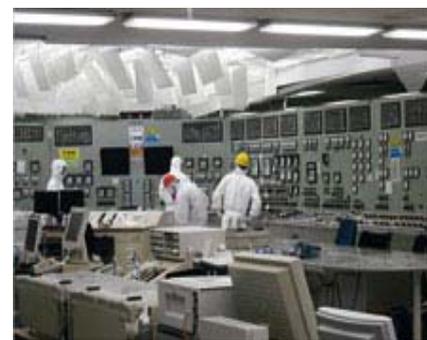
Figure 1. Station Blackout loss of power to the control room of the Fukushima Daiichi unit 1 reactor on March 24, 2011 (left). Restoring offsite power to units 1 and 2 and power to the control room of unit 2 on March 26, 2011

(right). The hanging ceiling tiles resulted from the earthquake. Source: Tepco.

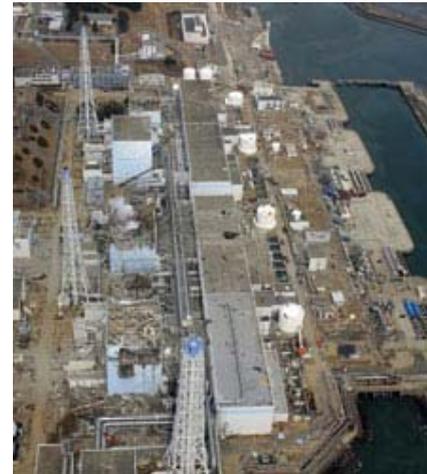
Figure 2. Aftermath of Fukushima Daiichi accident on March 18, 2011, one week after the accident. Rubble from hydrogen explosions in units 1, 3 and 4 is spread over the site. Damage from the earthquake and tsunami to the electrical systems is apparent along the water front. Steam still emanating from unit 2. Source: DigitalGlobe

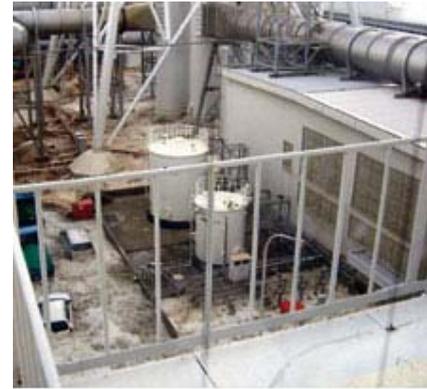
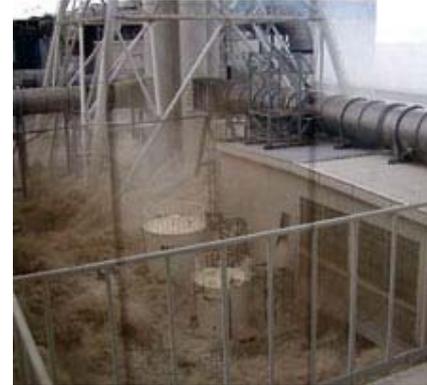
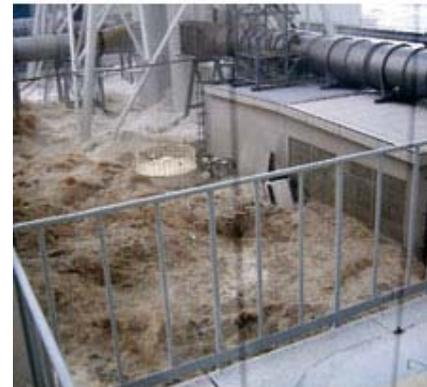
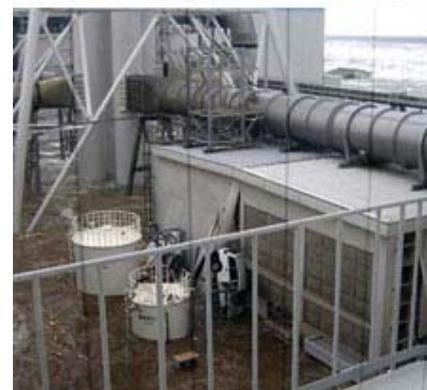
The following sequence of photos were taken from the 4th floor of the waste processing building at the power plant. They were shot over the course of a minute and reveal how quickly the tsunami inundated the area. Source: TEPCO

The most notable effect was the flooding of the below-grade parts of the plant particularly in the basements of the turbine halls as well as other buildings. The water level reached about 4.2 m in one turbine building. This disabled 12 of the 13 emergency diesel generators and affected their associated electrical switching gear as the sea water shorted the electrical circuits. Within an hour after the earthquake that started at 2:46 pm, at 3:41 pm all onsite power from the diesel generators had failed, plunging the plant into a full-fledged "station blackout."

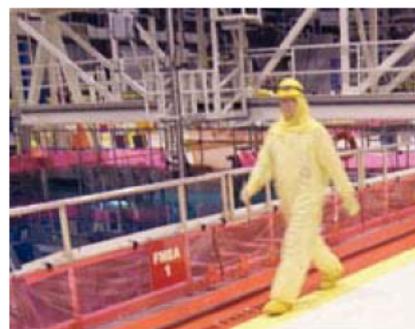
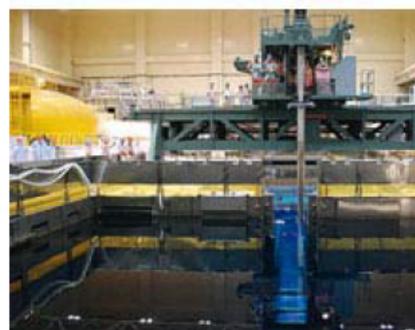
Figure 7. Spent fuel storage pools (top) showing fuel assembly being moved through gate between pool and reactor top. Yellow object is removed core dome. Steam emanating from the fuel storage pool in unit 4 on March 15, 2011, under the loading crane showing at the center of the picture (bottom).

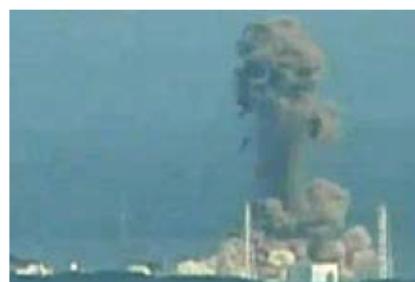
Figure 8. Highly energetic vertically propagating hydrogen or possibly steam explosion at the Fukushima Daichi unit 3 BWR on March 14, 2011 was followed by a fire and suspected reactor fuel damage. Heavy debris possibly composed of the concrete shield plug or crane components was vertically ejected and is seen falling back down in the photograph. No damage to the reactor pressure vessel can be inferred

from the absence of the reactor's top plug in the ejecta. Source: NTV / NNN Japan.

A more energetic presumed hydrogen explosion associated with steam depressurization followed at the unit 3 on March 14, 2011 with a fire and may have lead to pressure suppression pool damage. This unit uses a Mixed Oxide, MOX fuel mixture of UO_2 and PuO_2 which raised concern because of a lower melting point of Pu than U, as well as the combined chemical and radio-toxicity of Pu. The reactor core had 548 fuel assemblies and the storage fuel pool had 587 assemblies. The reactor containment vessel may have been damaged and spent fuel may have been uncovered. A suspected "long vertical crack" running down the side of the containment vessel was reported by a utility official. There is also a suspicion of molten corium material leaking onto the concrete base mat and interacting with it. The powerful explosion may have ejected components at the top of the reactor including concrete shield plugs and parts of a loading crane.

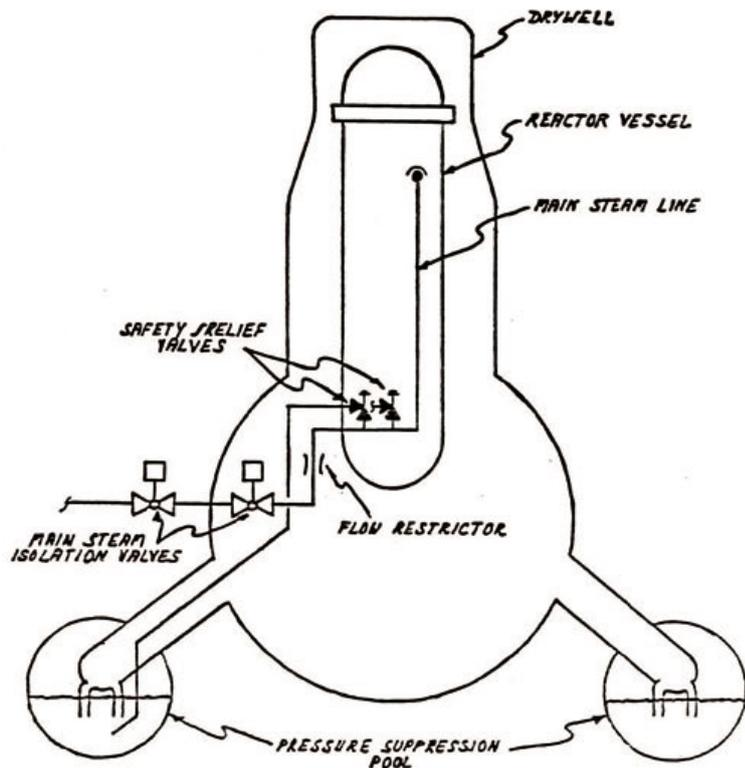
Figure 3. Main isolation valves and safety relief valves used in the depressurization of a BWR plant. Source: GE.

The nuclear pressure relief system protects the Reactor Coolant Pressure Boundary, RPCB against damage due to overpressure. Pressure operated main Safety Relief Valves, SRVs are available to discharge steam from the Nuclear Steam Supply System, NSSS to the pressure suppression pool.

The primary MSIVs automatically close to isolate the Reactor Coolant Pressure Boundary, RCPB in the event of a pipe break downstream of the outboard isolation valve. This procedure limits the loss of coolant and the possible release of radioactivity from the NSSS.

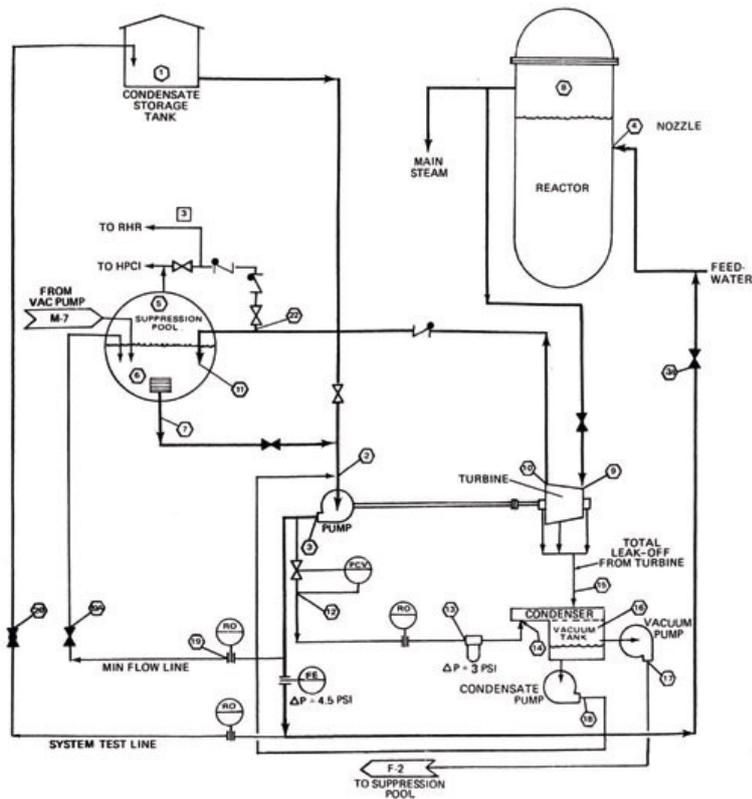
Figure 4. BWR Reactor Core Isolation Cooling system, RCIC. A steam turbine uses steam to drive a pump injecting water drawn from the condensate storage tank into the core. Exhaust from the steam turbine is directed to the pressure suppression pool. HPCI: High Pressure Coolant Injection system, RHR: Residual Heat Removal system. Source: GE.

Failure of the reactor cooling function carried out by the Reactor Core Isolation Cooling, RCIC system occurred in units 1, 2 and 3 at the Fukushima Daiichi site and at unit 4 at the Fukushima Daiini site; a situation stipulated in article 15, clause 1 of the "Act on Special Measures Concerning Nuclear Emergency Preparedness" in Japan.

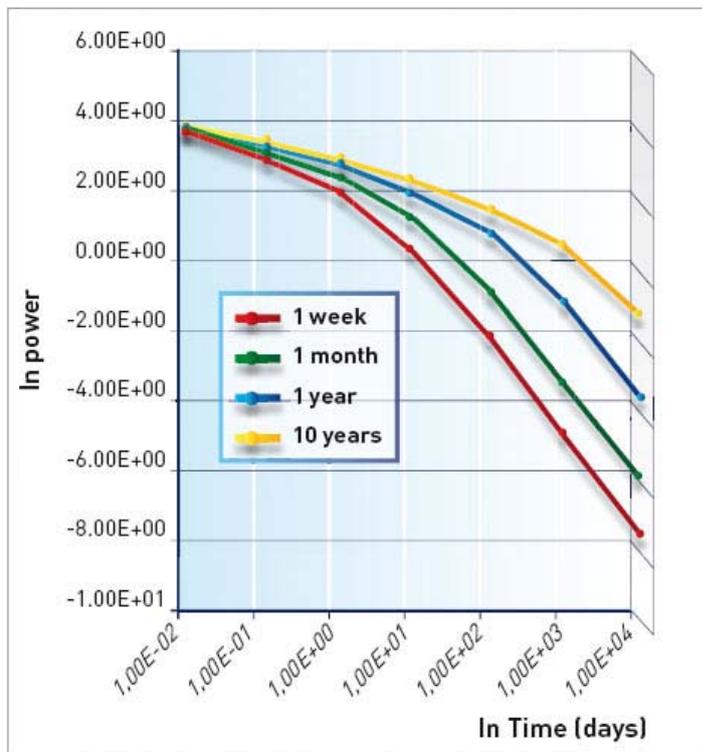
Figure 5. Decay heat power release for a 3,000 MWth Light Water reactor, LWR for different operational times. The decay heat generation power decreases exponentially within a few days after shutdown.

Upon shutdown of the fission power generation by the control rods, decay heat continued to be generated to an initial level of about 3 percent of the fission power at one minute after shutdown. It decreases exponentially as a function of time but must continue to be cooled over a few days period by the Residual Heat Removal, RHR system.

Assuming a plant thermal efficiency of 1/3, the thermal power of unit 1 would be $460 / (1/3) = 460 \times 3 = 1,380$ MWth. Initially, at one second or immediately after shutdown, thus $1,380 \times (6/100) = 82.8$ MWth of thermal power cooling has to be provided. At one minute after shutdown it rapidly decreases to $\frac{1}{2}$ the initial amount to: $1,380 \times (3/100) = 41.4$ MWth of thermal power cooling has to be provided.

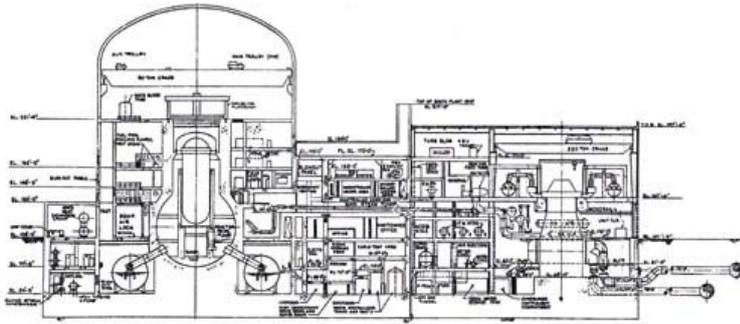
Figure 6. Cutout through containment and turbine hall showing the location of the fuel storage pool in a typical BWR. Components below grade level and hence affected by flooding from the tsunami event include pumps and electrical components. The dry well includes a sump. Any leaking molten corium material through the control rod seals could interact with the sump water as well as the concrete mat causing a steam explosion, then becoming embedded into the concrete. Source: GE.

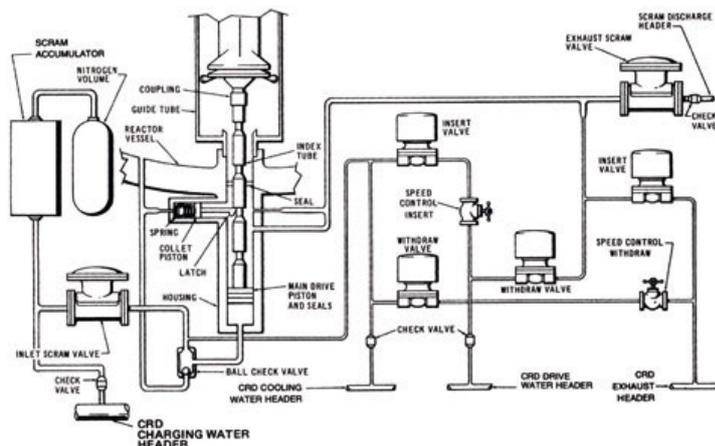
Figure 9. BWR control rod drive mechanism at the bottom of a BWR reactor vessel showing the seal location [2].

Based on the principle of “leak before break” in accident analysis, another explanation has been advanced for the occurrence as being possibly related to leakage through the control rod seals at the bottom of the reactor vessel. Boiling water reactors have their control rods inserted from the bottom of the cores. They are equipped with a graphite stopper covering each control rod penetration that seals the primary cooling water. At temperatures above 350 oF, the graphite stoppers mechanical properties would begin to deteriorate.

It was suggested that as the debris from the damaged fuel rods collected at the bottom of the reactor vessel the seals may have been damaged by high temperature. If the graphite seals fail, water in the reactor would leak into a network of pipes in the containment structures and auxiliary buildings associated with the reactor.
